INCIDENT INVESTIGATION #184651

2691 Meadows Dr

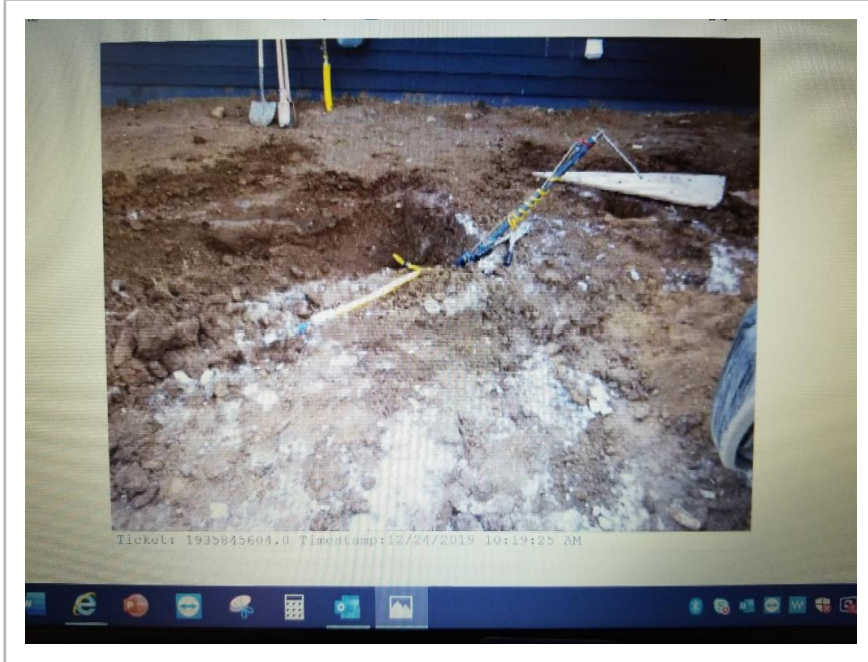
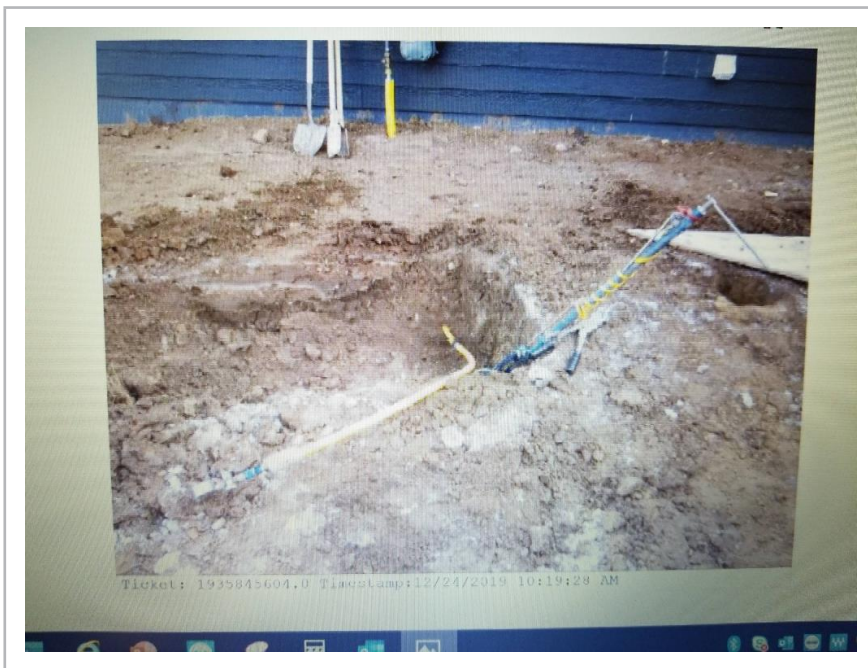
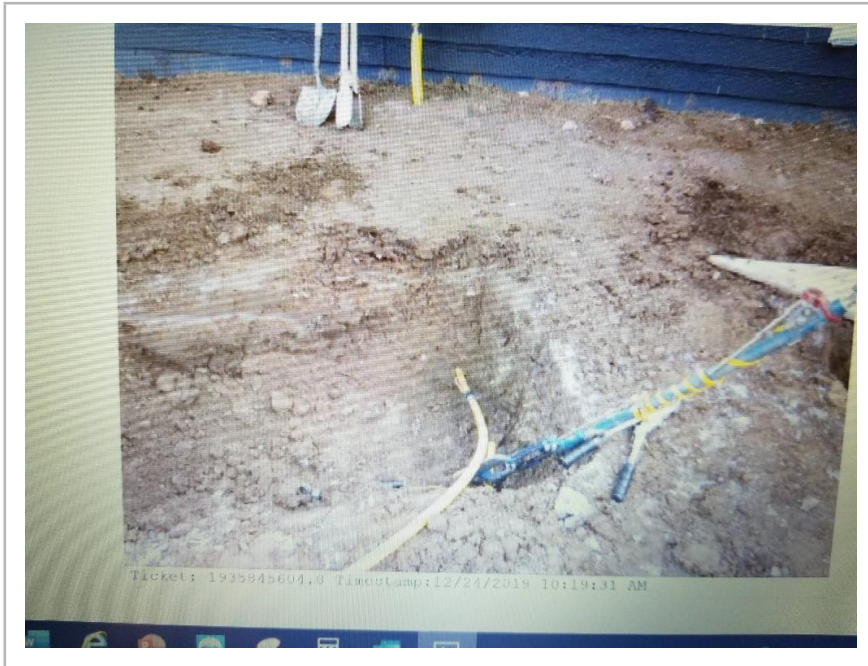
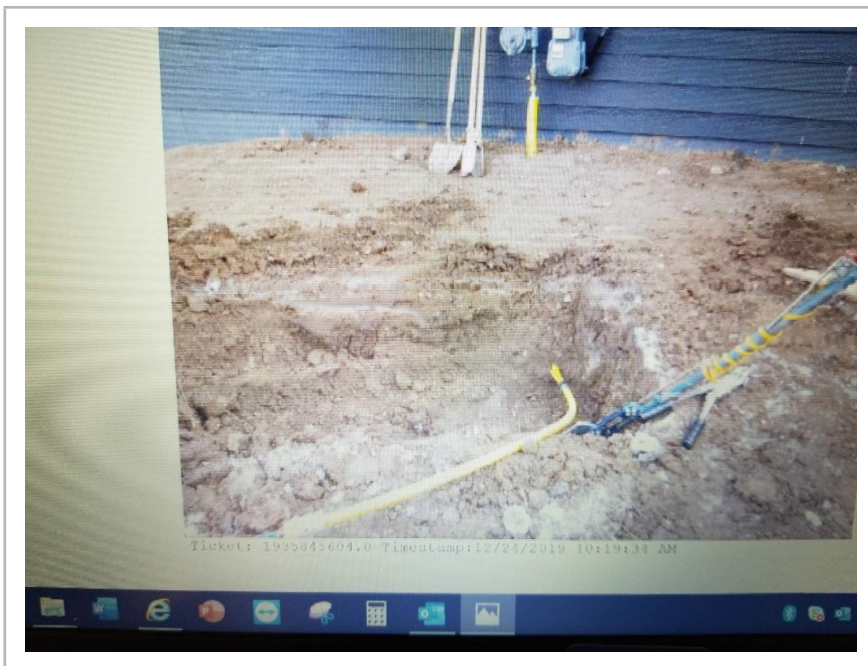
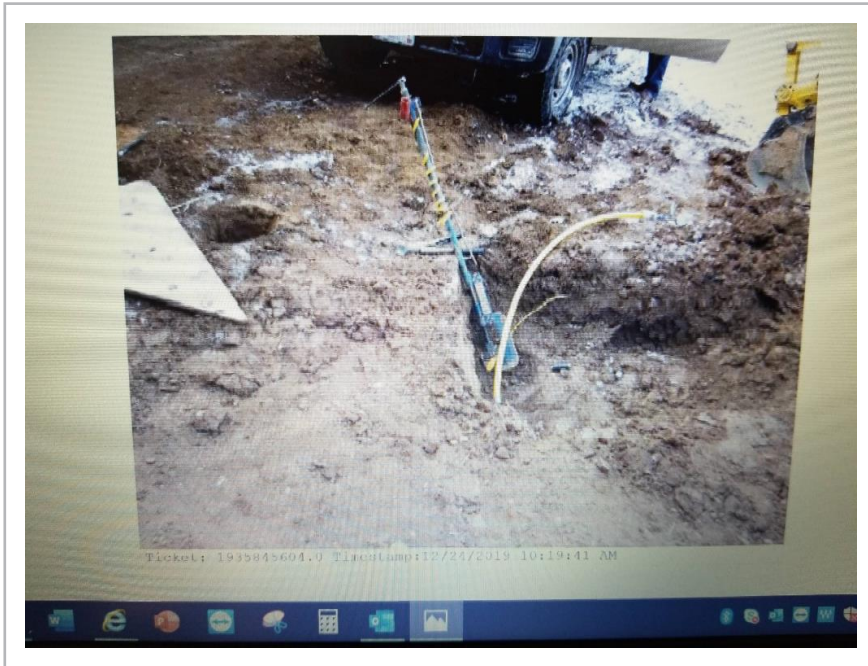
Assessment Comments: On December 24 the contractor digging without a locate request at 2691 meadows drive in Sturgis South Dakota cut in half the plastic service which was a 3/4 inch MDU plastic gas service with a power auger. 811 was called 911 was not. Gas was not blowing due to a EFV valve Contractor on site thought that his boss had called and locate tickets his boss was on vacation and no locate Was requested.
