INCIDENT INVESTIGATION #193625

0 E Mall Dr, Box Elder, SD

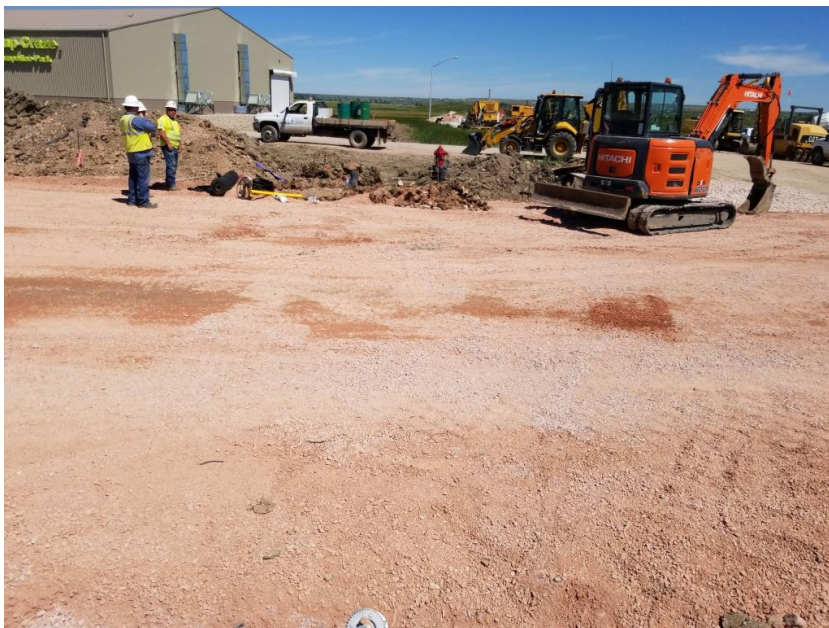
INCIDENT COMPARISON PHOTO

Assessment Comments: Excavator said he was only going to go down 21" went down a little to far right over top of the marks and poked a tooth from a track hole into a 2" plastic gas main. He said he looked on the South side of the road where the gas is 4 and a 1/2 feet deep and thought it was probably this deep on the North side of the road too. The original dig ticket from June 3rd has expired. Gas was blowing, 911 and 811 were notified.
