## INCIDENT INVESTIGATION #195810

704 Pahasapa RD, Rapid City, SD

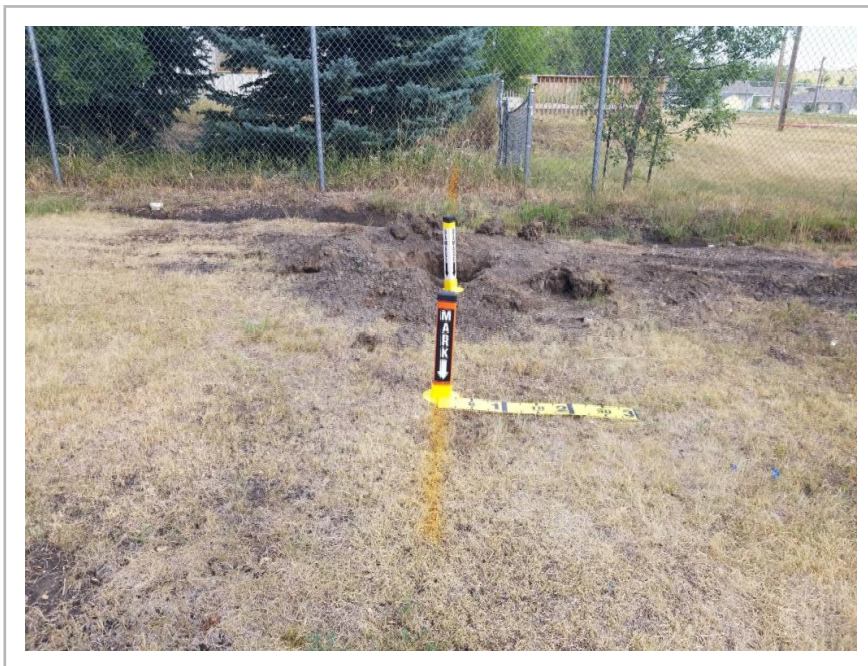
## INCIDENT COMPARISON PHOTO

**Assessment Comments:** On August 27th the contractor Underground Solutions using a trencher dug in to a accurately located and marked 3/4 inch plastic Montana Dakota Utilities gas service ripping a hole into the line causing it to blow. 911 was not notified 811 was notified.
