INCIDENT INVESTIGATION #198080

3682 Remington, Rapid City, SD

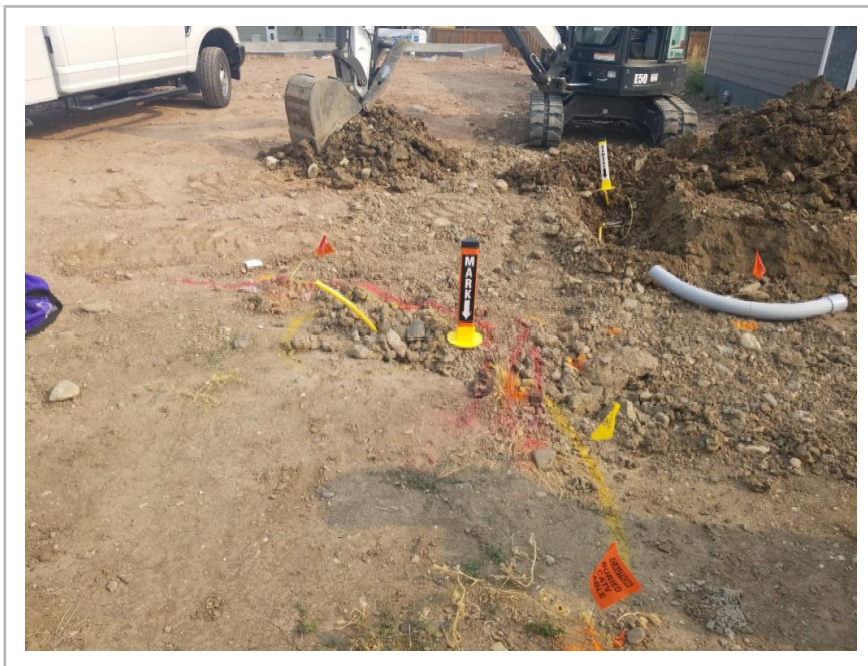
INCIDENT COMPARISON PHOTO

Assessment Comments: On September 17th Shane Geidel of Geidel Excavation dug through a Montana Dakota Utilities 3/4 inch plastic gas service that was not located. The gas riser was in plain view within 5 feet of where he was digging. Geidel does not have a locate request in his Name. Gas was not blowing 811 was notified.
