INCIDENT INVESTIGATION #198188

O Katie Lane & Pine View Dr, Sturgis, SD

INCIDENT AND SURVEY COMPARISON PHOTOS

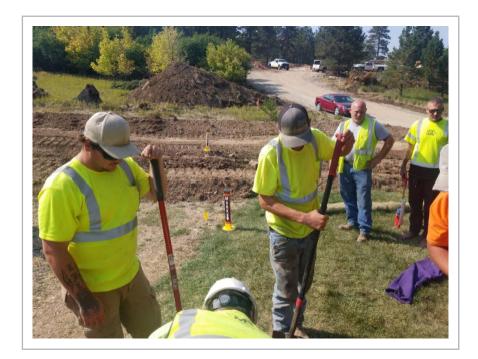
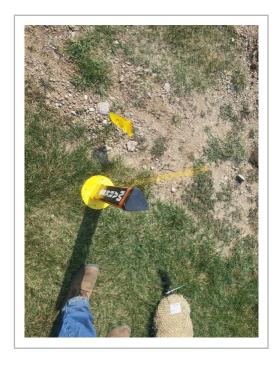
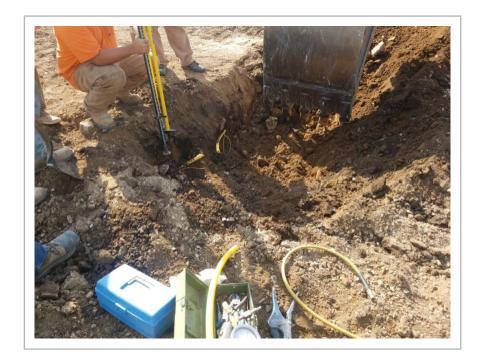
NEW INCIDENT PHOTOS

Assessment Comments: I received the notification around 1:30 PM on September 23 that the gas was hit at Katie Ln. MDU was on site when I arrived. 2 MDU trucks and 3 MDU personel were present. 911 was notified. 811 was notified. Gas was blowing from 1:15 until 2:20 pm. The gas line was fixed around 3:00 PM. The gas line was aprox 6 inches deep. Work being done was grading a road, and area was marked accuratley with flags and paint prior to digging.
