INCIDENT INVESTIGATION #198537

3715 Hills View, Spearfish, SD

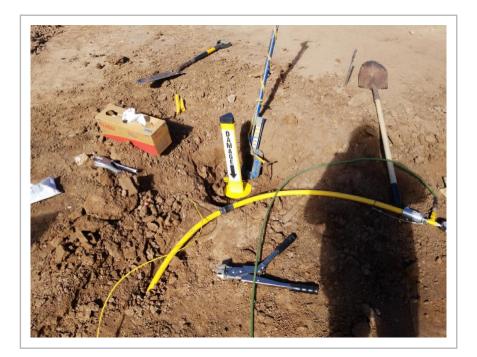
Assessment Comments: Got called at 1:18 for a gas damage at 3715 Hillsveiw Rd. MDU tech was on sight fixing the line when ELM showed up. Gas was not blowing. 911 was not called but 811 was. No locate ticket. Contractor was not on sight when locator showed up. Information was exchanged via MDU tech And ticket info.
