## INCIDENT INVESTIGATION #198581

649 Liberty Park Dr, Box Elder, SD

**Type of Operation Affected:** Gas

**Line Size and Type:** 0.75" Plastic

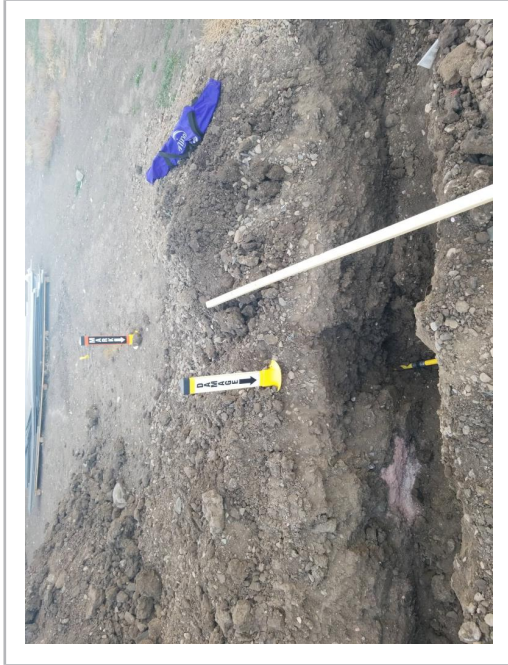
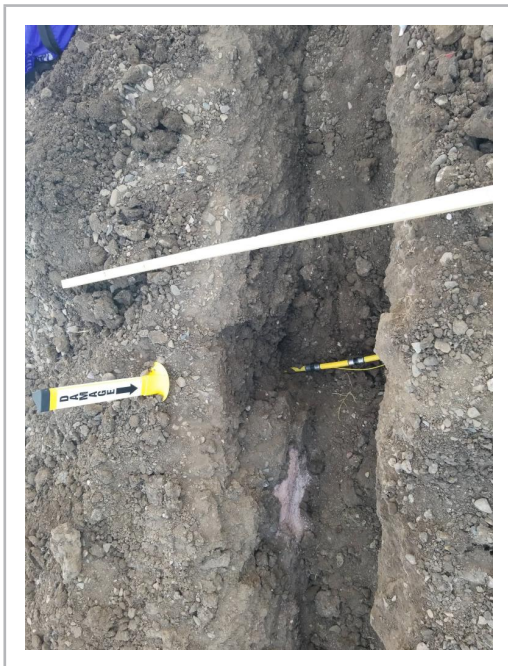
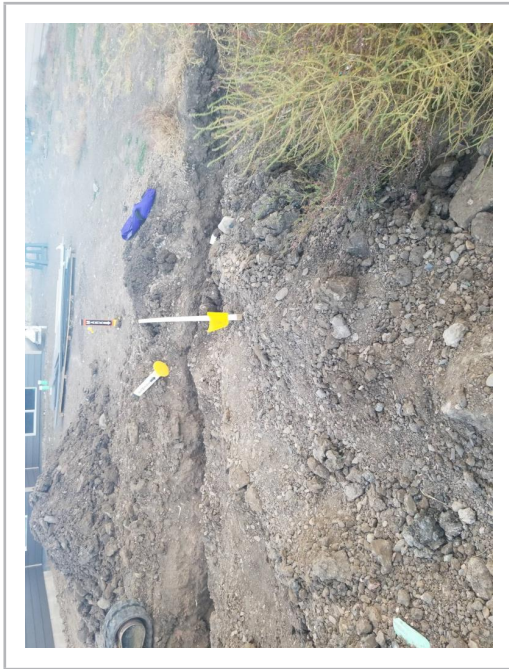
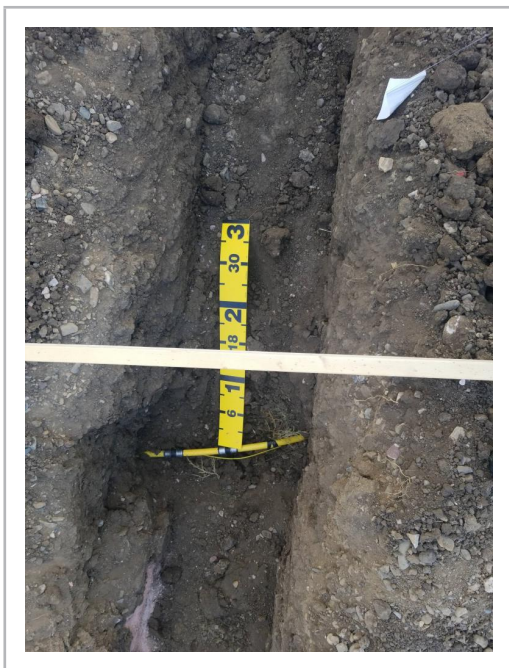
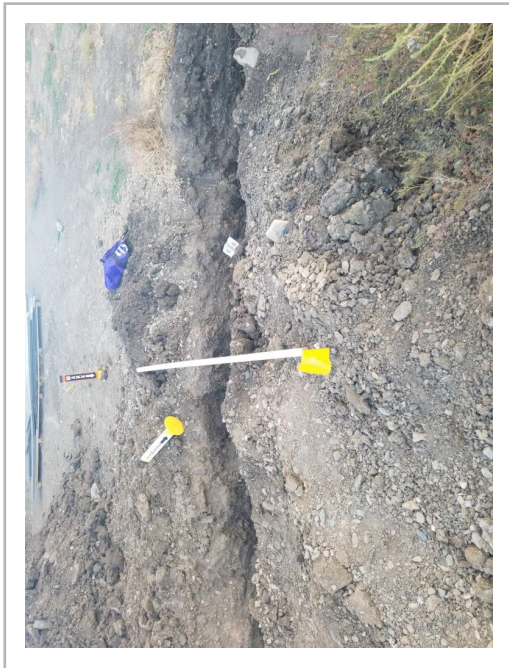
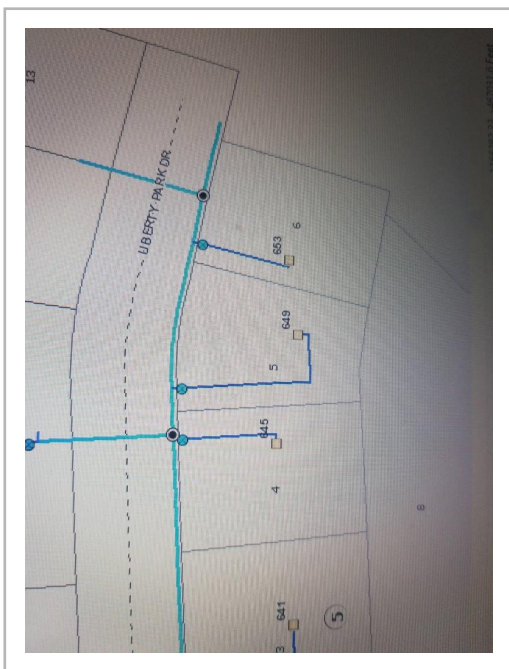
**Assessment Comments:** Excavator was digging off Locates that were done for CCS. The contractor cut a Montana Dakota utilities gas service in half with a mini excavator. Gas was blowing and 911 and MDU were notified. 811 was not called. The contractor does not have a locate ticket the pictures were taken using markings that were put down for CCS and construction had ruined all the markings in between the damage kit markers so we just straight lined between them but they still fell within 18" even though this contractor does not have a ticket we thought it necessary to include the locates and measuring tools on the damage investigation. no attempt was made to find the gas service and verify its location.
