INCIDENT INVESTIGATION #202106

5808 Eastside Dr, Blackhawk, SD

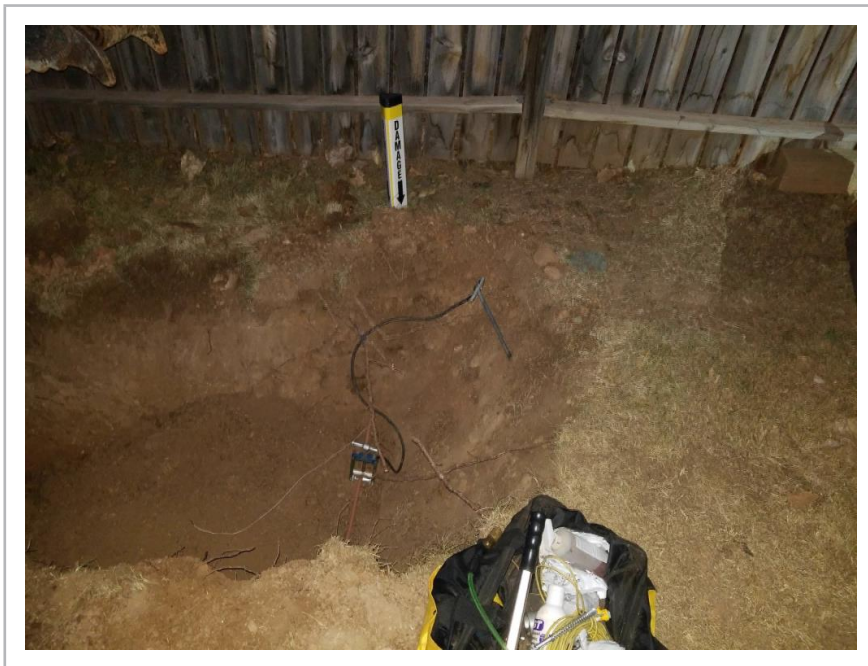
Assessment Comments: On November 30th the contractor using a Mini Excavator dug into and cut in half the half inch MDU plastic service gas was not blowing the contractor pinched off the line 811 and 911 were not notified.
