INCIDENT INVESTIGATION #203141

5630 Bing, Rapid City, SD

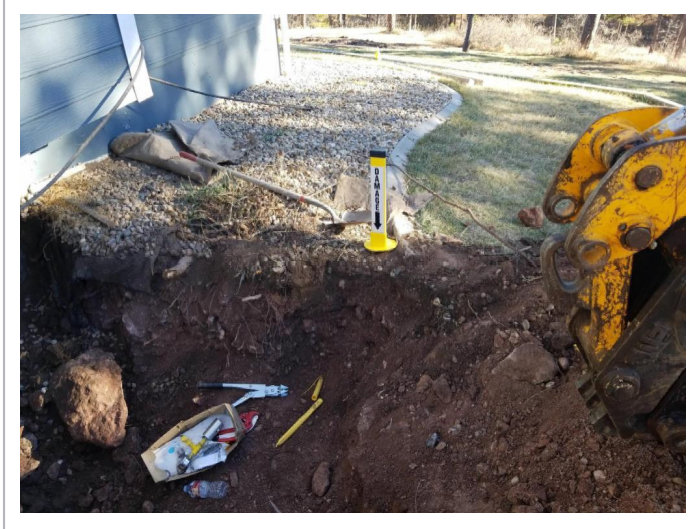
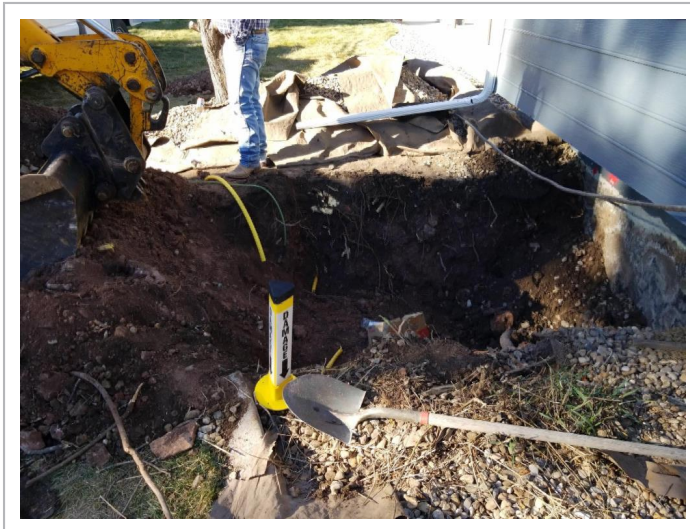
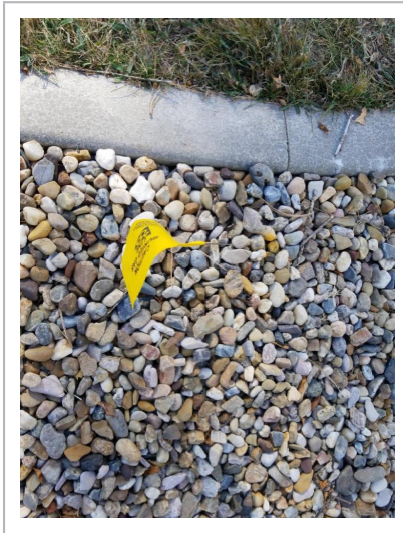
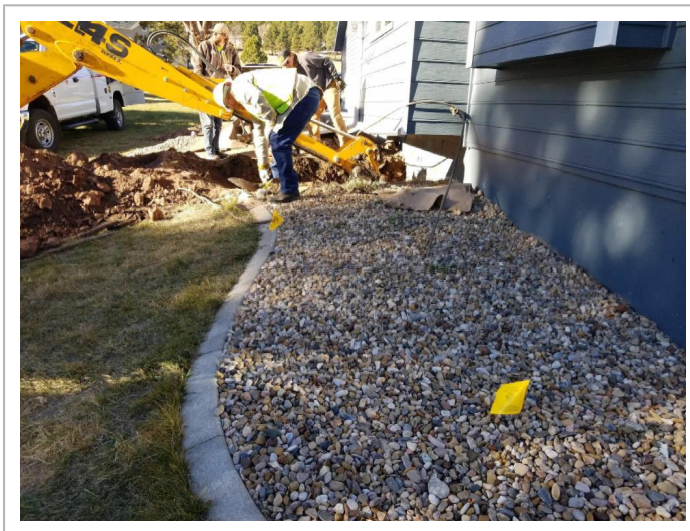
Assessment Comments: On December 4th the contractor installing and egress window with a backhoe cut the Montana Dakota utilities 3/4 inch plastic service In half. Gas was blowing, 911 was notified 811 was notified. The contractor does not have a locate request However there were marks and flags from a locate for septic system work by Solseth Excavation that stopped a few feet from the egress window excavation That were clearly visible and flagged.
