INCIDENT INVESTIGATION #194021

0 Woodlawn Dr, Rapid City, SD

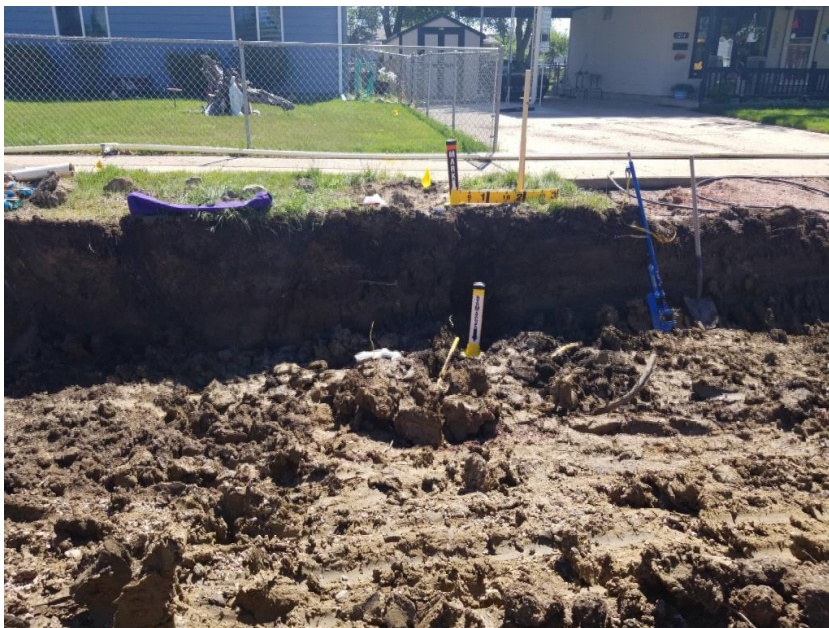
INCIDENT COMPARISON PHOTO

Assessment Comments: At 9:54 am on July 15th a MDU 3/4 inch plastic service line was hit by JMD Excavating. The line was hit about 3 feet from the main in the east row of woodlawn drive. The only locate marks remaining in that area were where the main was and where the service ties into the main. All locate marks heading to the west were destroyed by construction. Taking the comparison pictures was a little bit of a challenge since there was a large pile of dirt where I had originally stood. Based on the locate marks present and the comparison pictures the damage occurred within 18 inches of the marks that were there. Gas was not blowing 811 was notified.
