INCIDENT INVESTIGATION #193920

0 Westwind Rd, Boxelder, SD

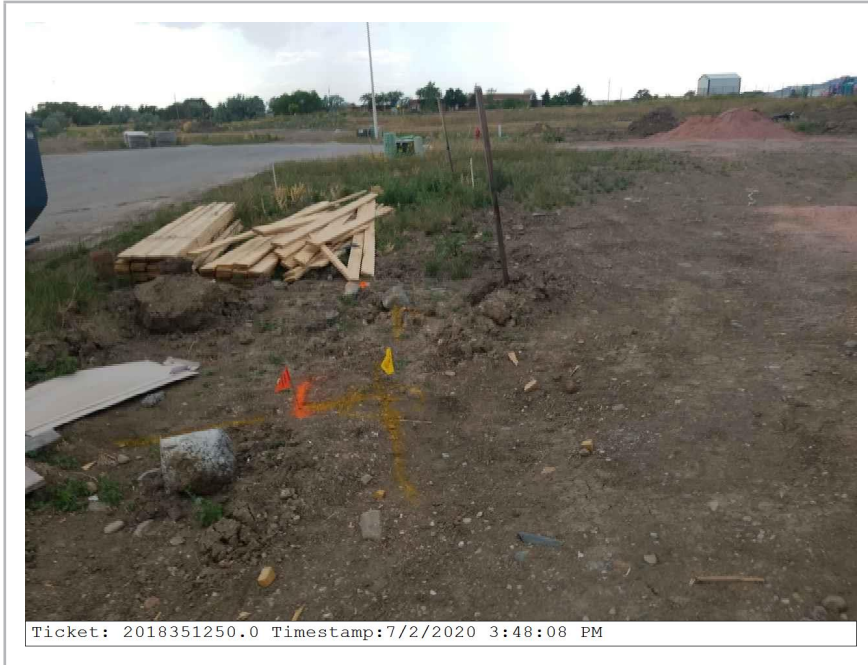
SURVEY PHOTO

Assessment Comments: A gas damage occurred on July 9th on Westwind road near the end of the cul-de-sack in lot 6b. The contractor Kyle Nelson struck the 2 inch plastic gas main causing a puncture in the line with the tooth of a backhoe. Gas was blowing. MDU was called as well as 911, and 811. There were still some visible locate marks on the ground but it looks like the ones to the western edge of the property had been destroyed during construction. Comparison photos show that the main was located correctly.
