## INCIDENT INVESTIGATION #198581

649 Liberty Park Dr, Box Elder, SD

**Type of Operation Affected:** Gas

**Line Size and Type:** 0.75" Plastic

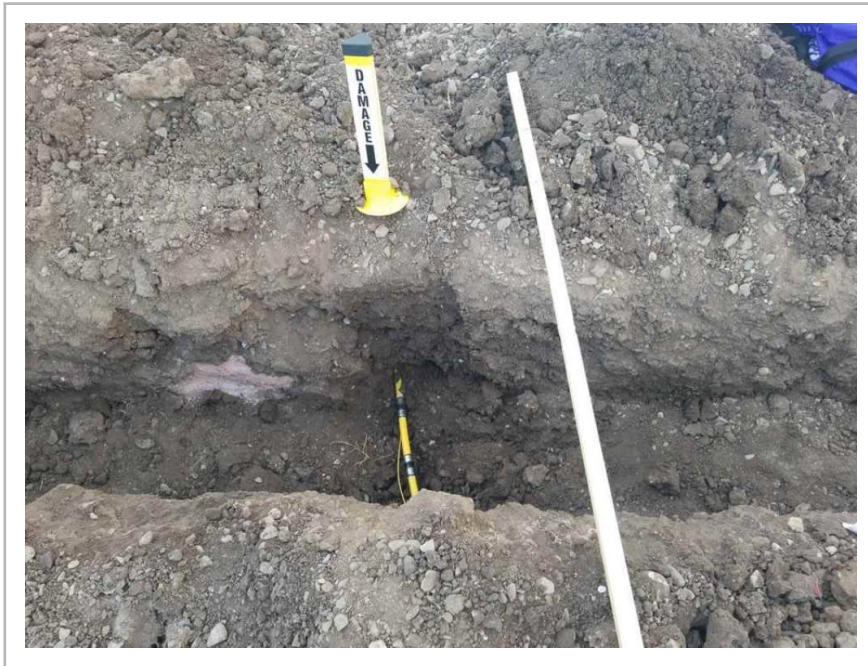
**Assessment Comments:** Excavator was digging off Locates that were done for CCS. The contractor cut a Montana Dakota utilities gas service in half with a mini excavator. Gas was blowing and 911 and MDU were notified. 811 was not called. The contractor does not have a locate ticket the pictures were taken using markings that were put down for CCS and construction had ruined all the markings in between the damage kit markers so we just straight lined between them but they still fell within 18" even though this contractor does not have a ticket we thought it necessary to include the locates and measuring tools on the damage investigation. no attempt was made to find the gas service and verify its location.
