INCIDENT INVESTIGATION #184699

3525 E Colorado Blvd

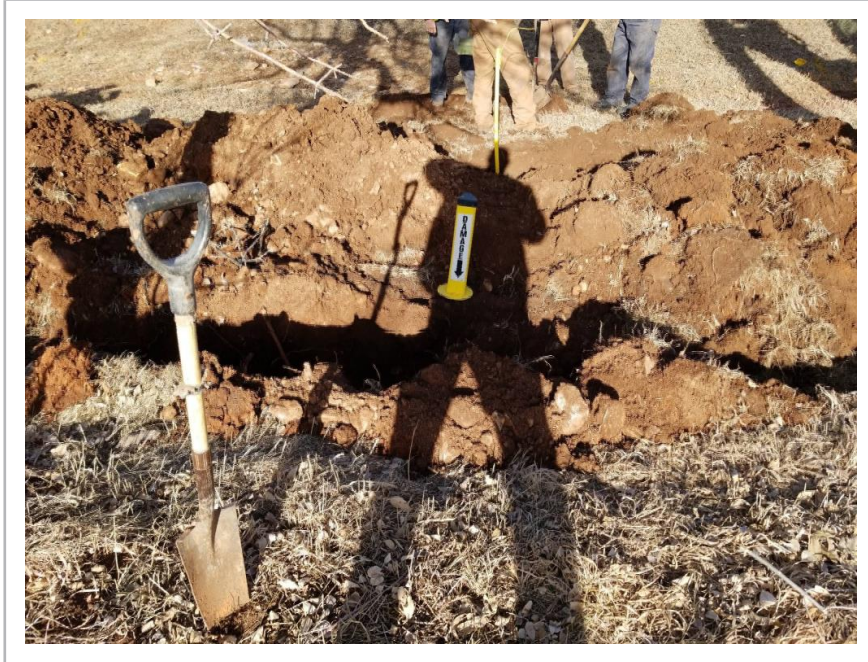
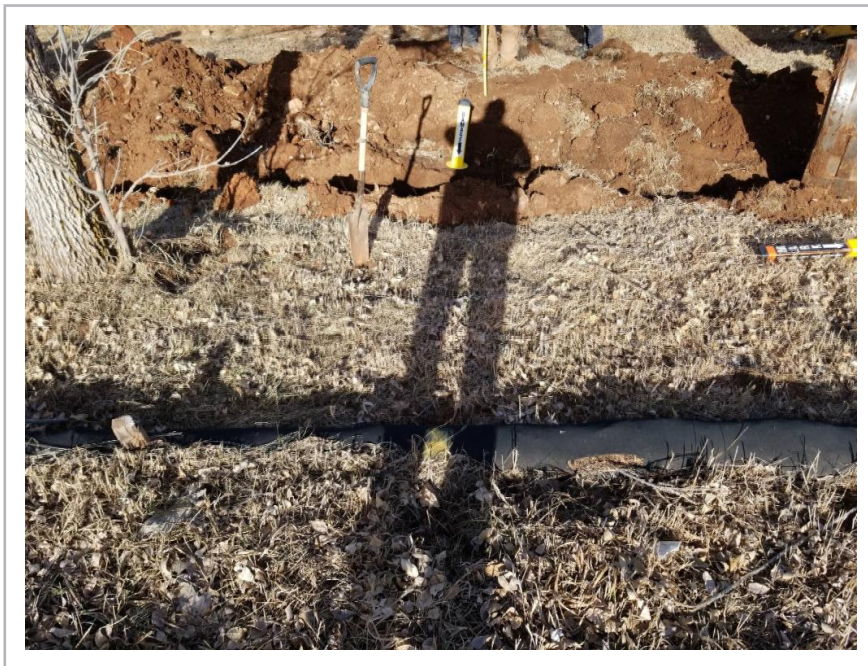
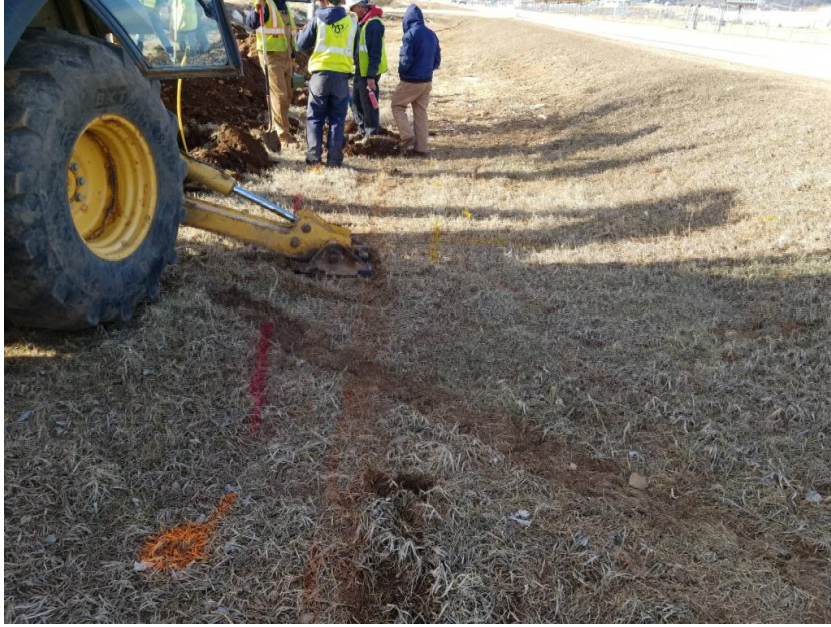
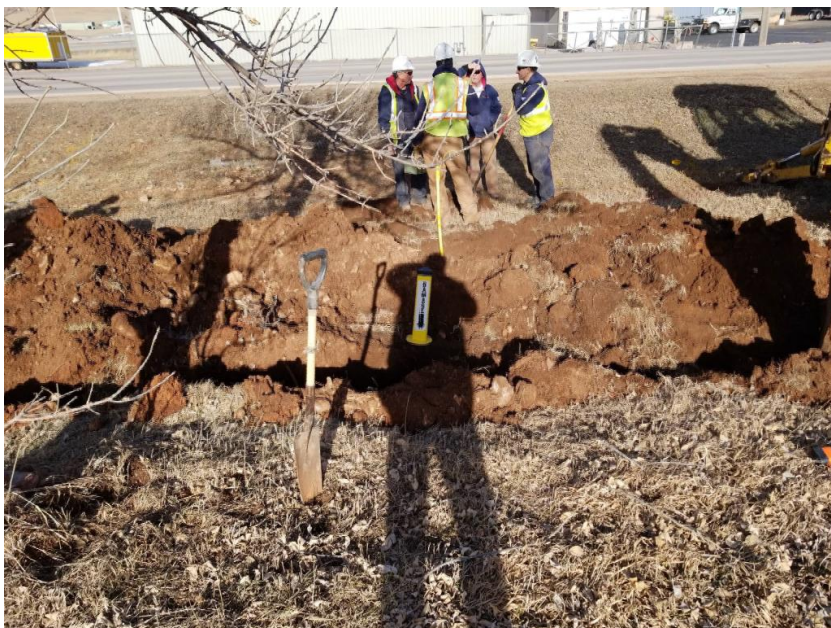
NEW INCIDENT PHOTOS

Marking Standards Comments: Line was measured according to Montana Dakota utilities Prints but their Prints are off by approximately 10' Montana Dakota utilities is taking responsibility for the Damaged stub.

Assessment Comments: Called to damage 1225 pm 3/4in pl stub was hit .line form was put in 911 was called 811 was called MDU was called line was marked using measurements but measurements on prints are wrong line was cut in half. gas was blowing
