## INCIDENT INVESTIGATION #188121

607 Franklin St

**Type of Operation Affected:** Gas

**Line Size and Type:** 0.75" Plastic

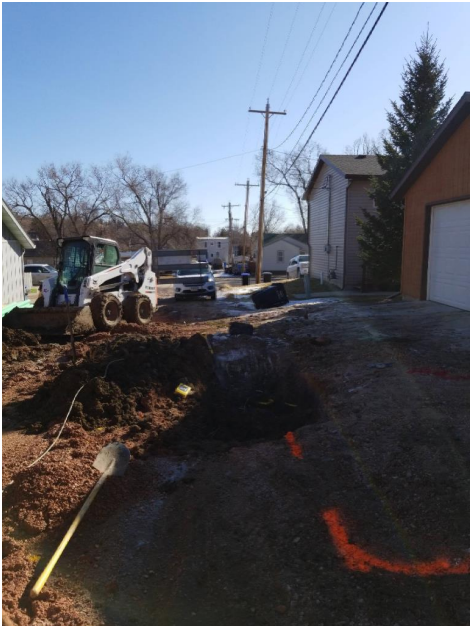
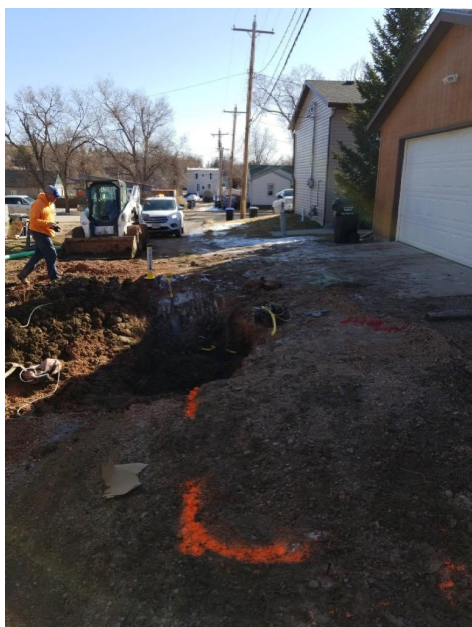
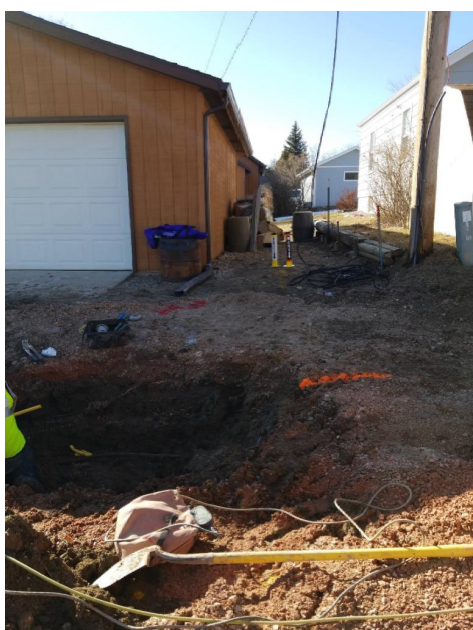
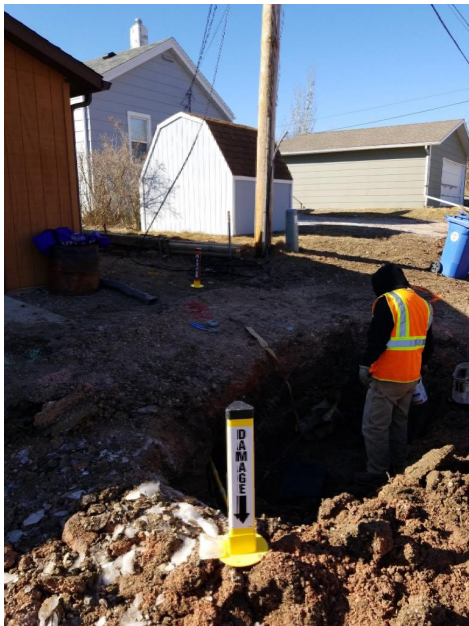
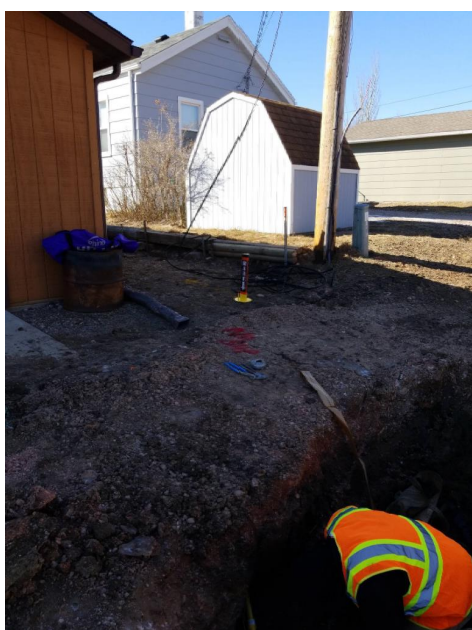
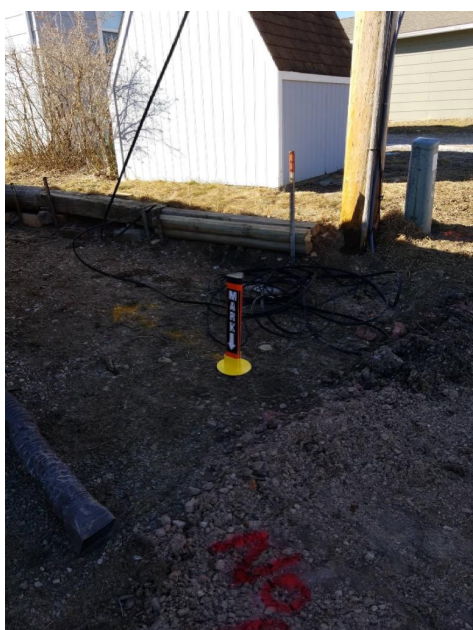
## INCIDENT COMPARISON PHOTO

**Assessment Comments:** On March 5th the contractor was digging up a damaged phone line in the alleyway that they nicked during this house demolition a day or two ago for the repairs when they hit the gas service that came across the alley to the gas main they had covered up the marks with dirt and gravel in the alley and forgot the line was there and damaged it with a excavator gas was blowing 811 was called 911 was not called the line was cut in half
