## INCIDENT INVESTIGATION #193296

Sheridan Lake Rd, Rapid City, SD

# INCIDENT AND SURVEY COMPARISON PHOTOS

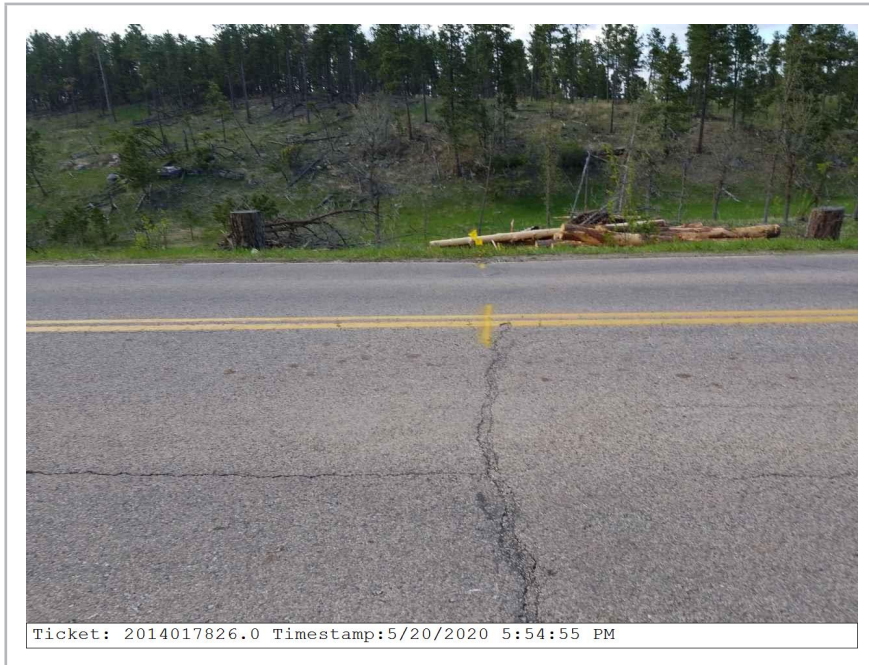
## SURVEY PHOTO

Date: 05/20/2020 05:54 PM undefined

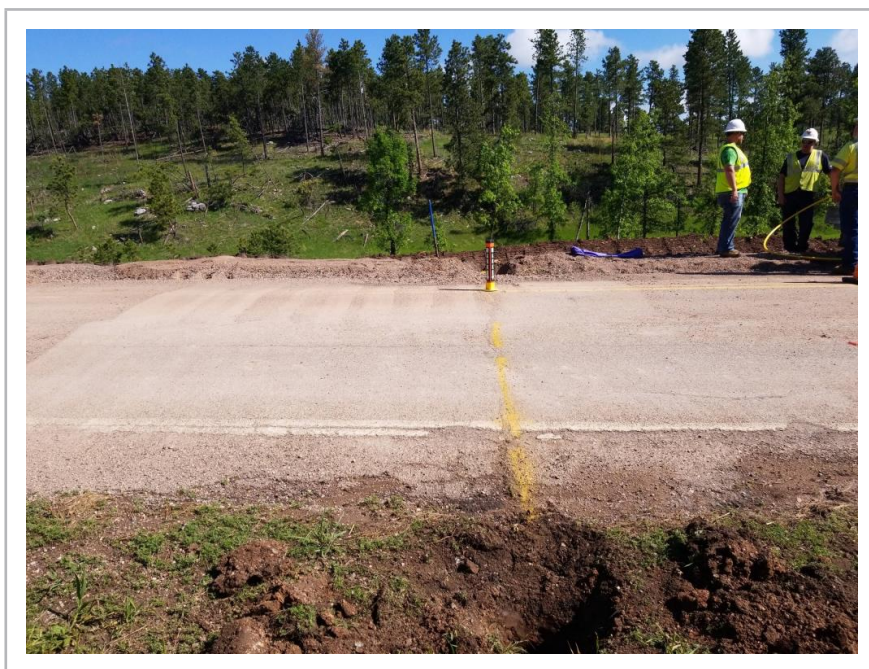
## INCIDENT COMPARISON PHOTO

Date: 06/05/2020 10:23 AM undefined

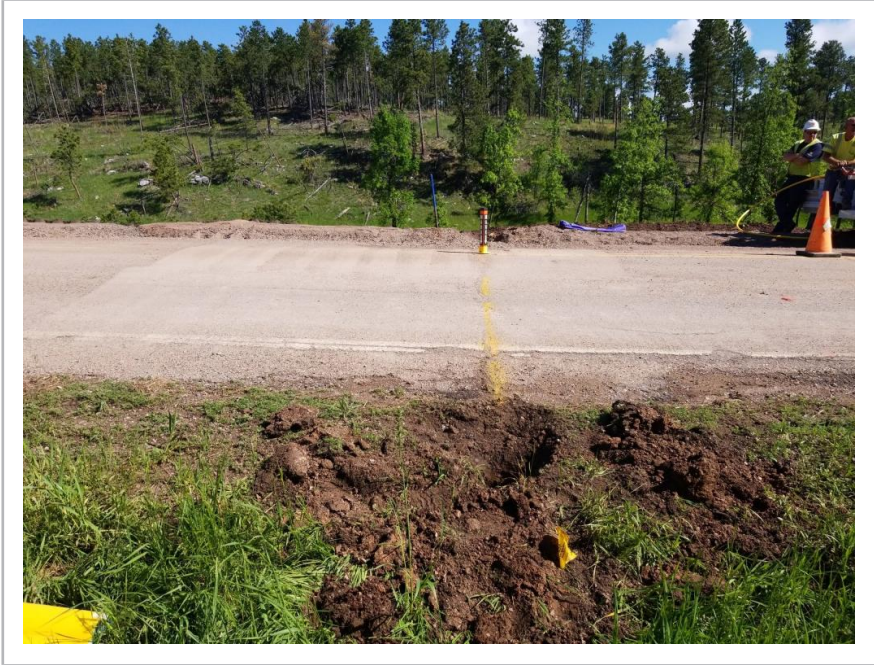
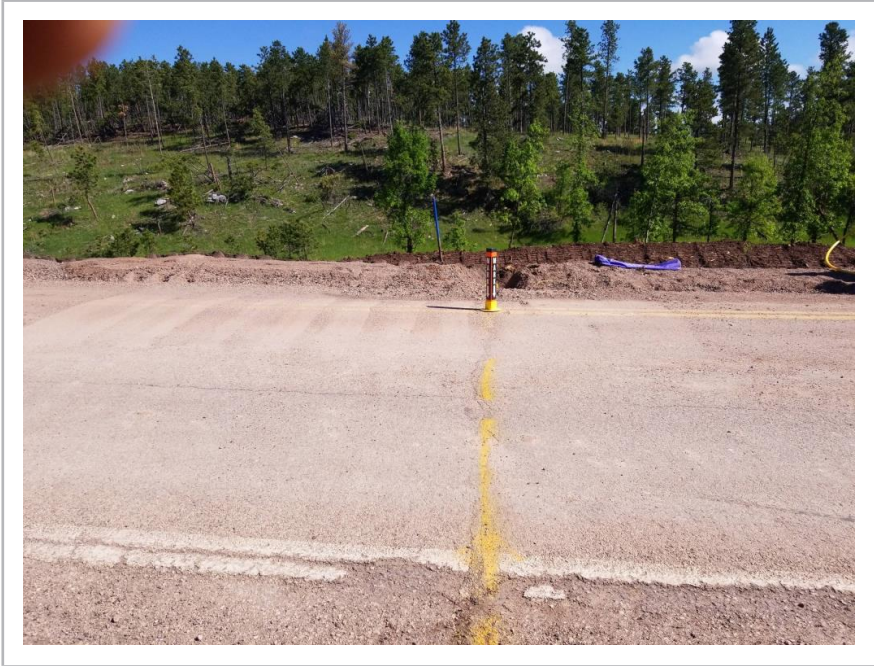
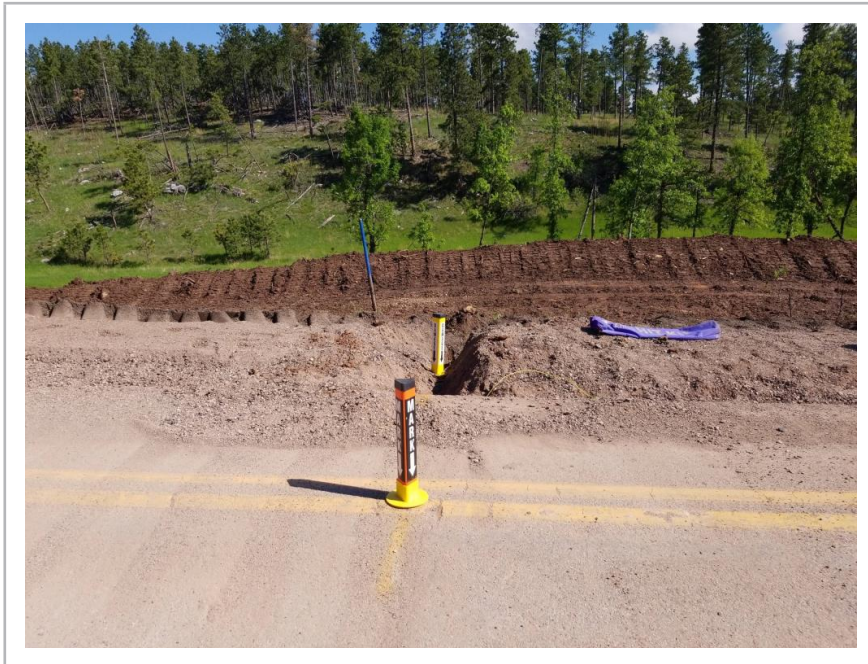
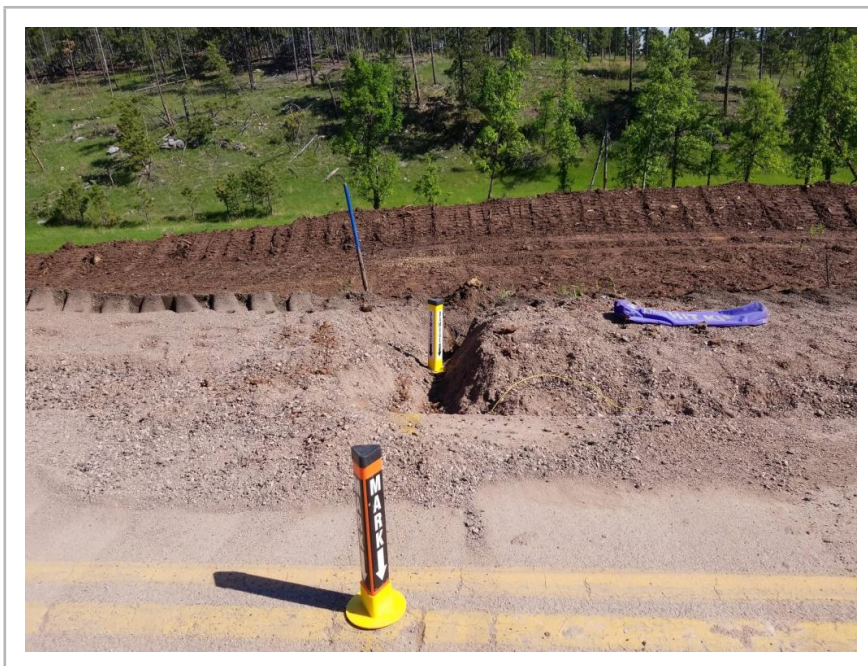
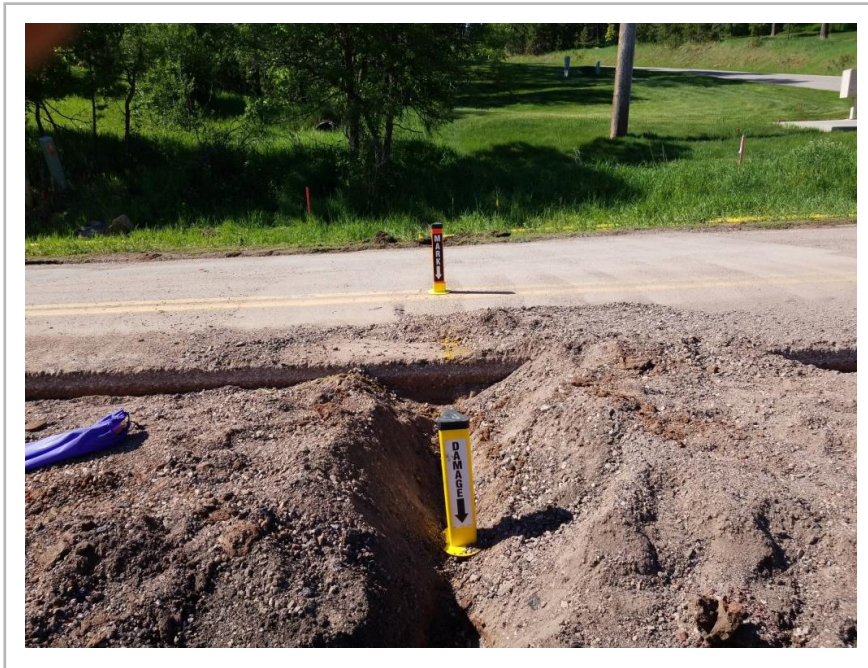
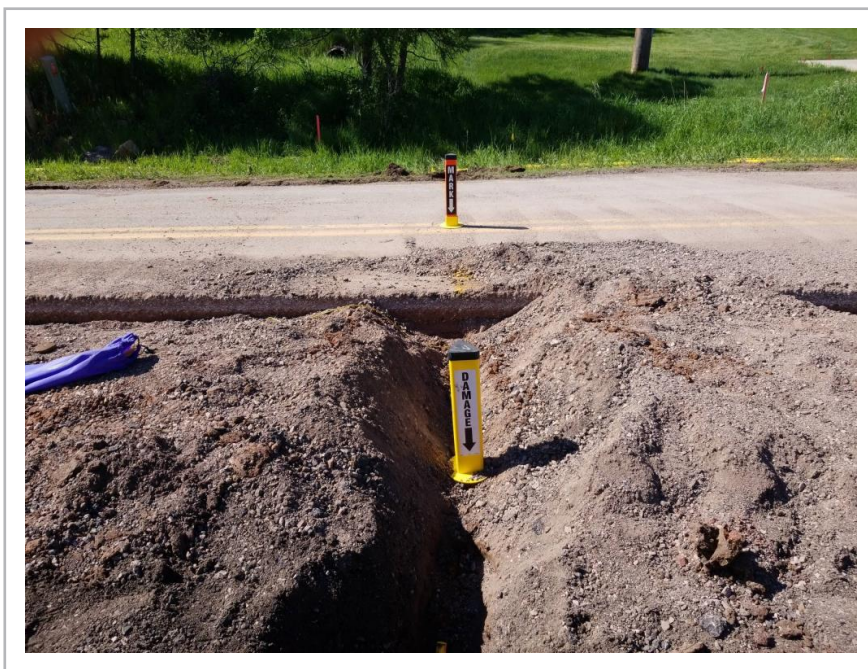
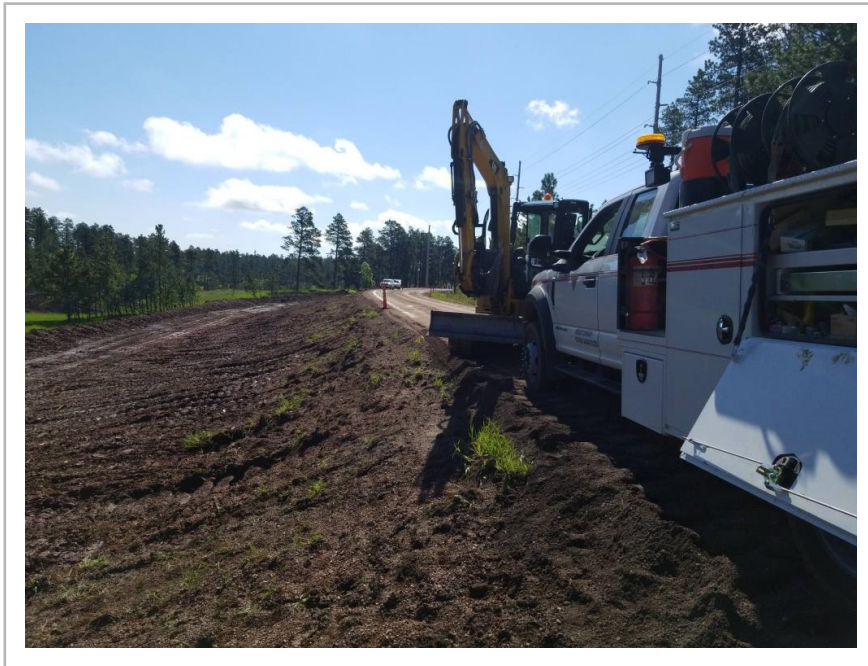
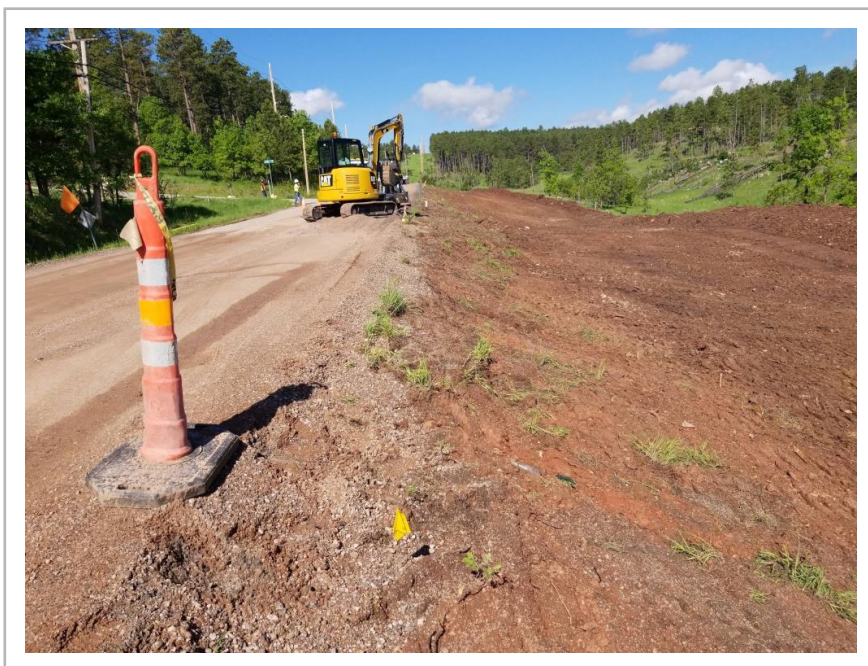
# NEW INCIDENT PHOTOS

**Assessment Comments:** On June 5th the contractor Industrial Builders was milling the road at Sheridan Lake road working without a locate request in their name. the contractor that actually has the locate called in is Ostedal Construction. Industrial builders was running a milling machine when they hit the Montana Dakota utilities 3/4 inch plastic service. The locate marks were clearly accurate from the locates performed for Ostedal Construction. Gas was blowing, 811 and 911 were both notified.
