INCIDENT INVESTIGATION #193776

Summerset Dr & Sunny Hill Circle, Rapid City, SD

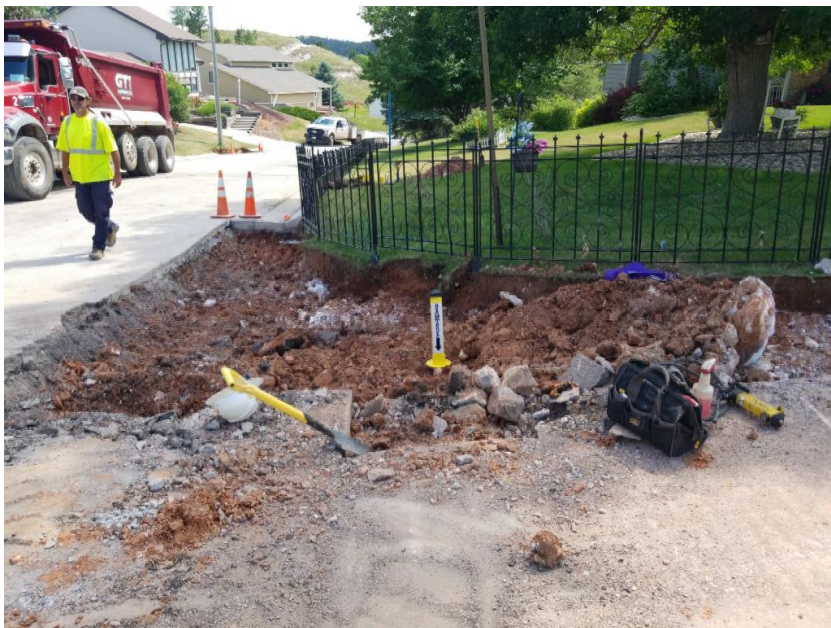
INCIDENT COMPARISON PHOTO

Assessment Comments: The gas damage occurred Wednesday July 1st around 1 pm. A 2 inch plastic Montana Dakota Utility gas main was damaged by a backhoe at the southeast corner of the intersection of summer set drive and sunny hill circle. When talking with the contractor Darrell, he wasn't able to give me a locate ticket number. There might not have been a locate ticket called in. It appears that they were using the locate marks from a ticket I had done for the city for a service line replacement - ticket 2017646309. So the comparison photos in the report are for locate for the city and not GTI. The photos were added to the report to help clarify the citation. GTI does not have a locate request and the work area they are working in is not even in the same area as the City of Rapid City's locate that they requested but the markings ended and were accurate at the point they were digging. Gas was blowing 911 and 811 were notified.
