## INCIDENT INVESTIGATION #195095

W Elm St and Logan St, Blackhawk, SD

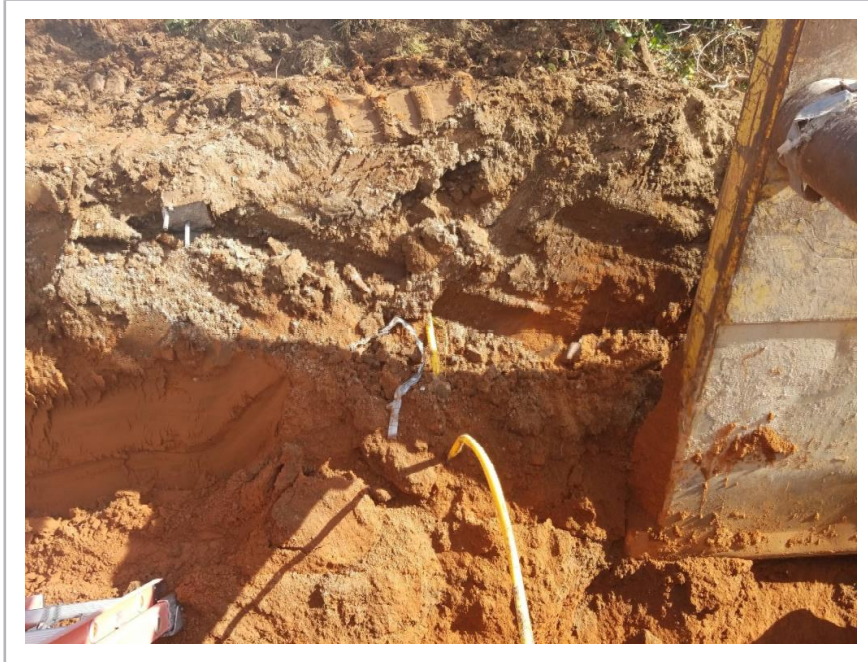
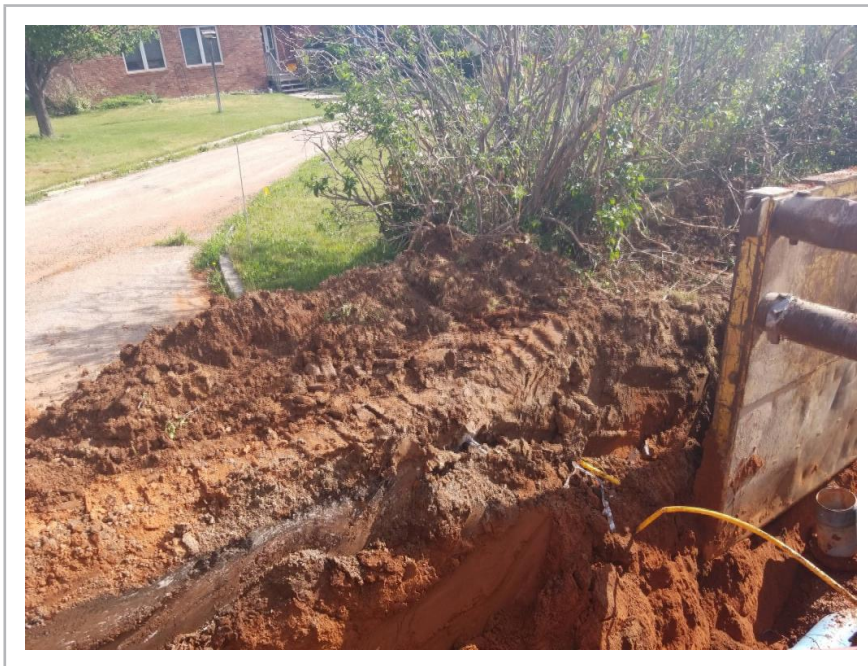
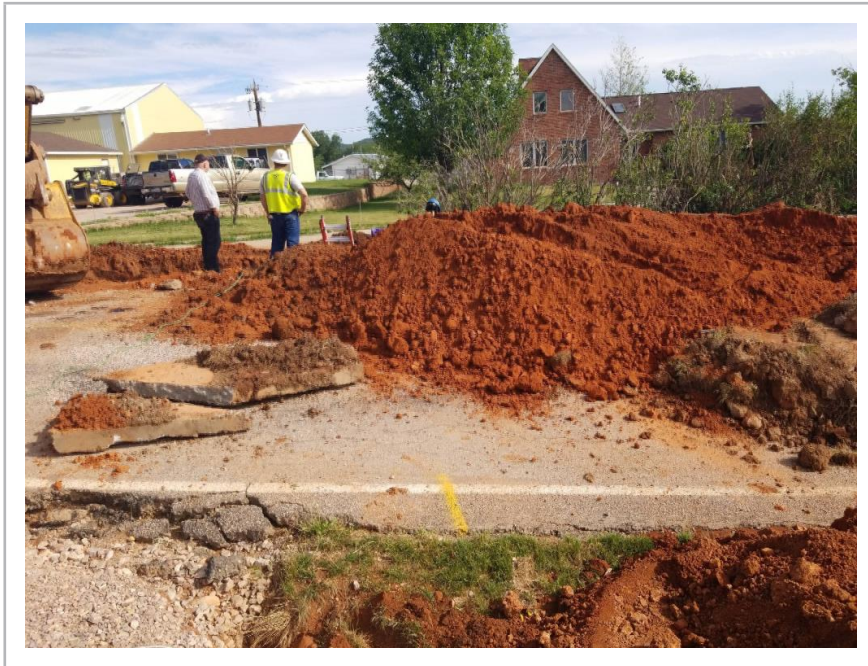
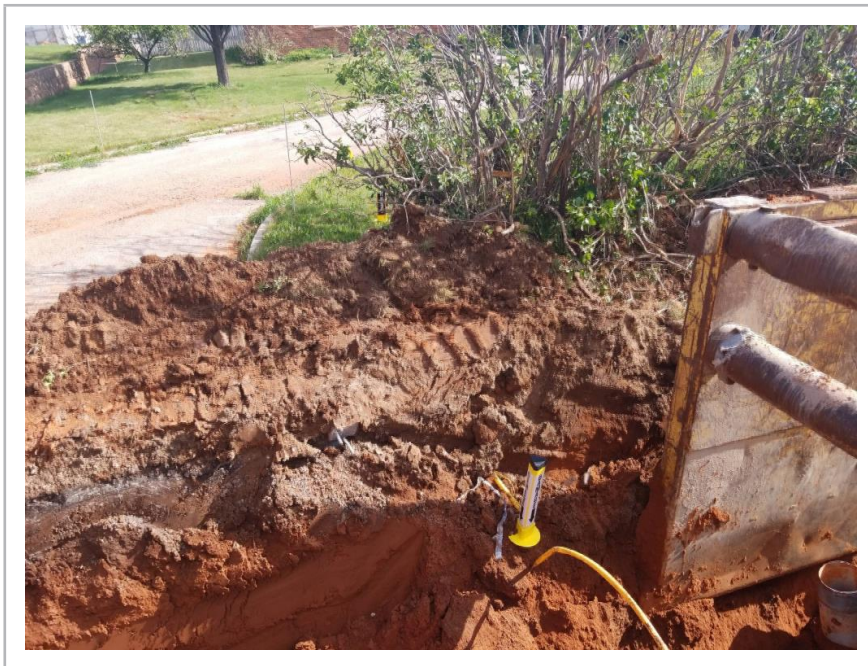
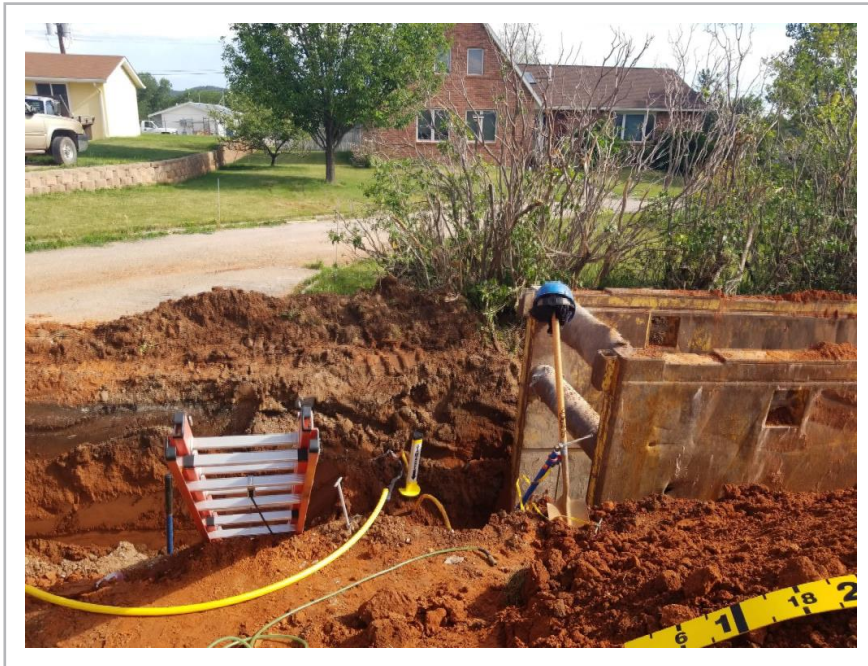
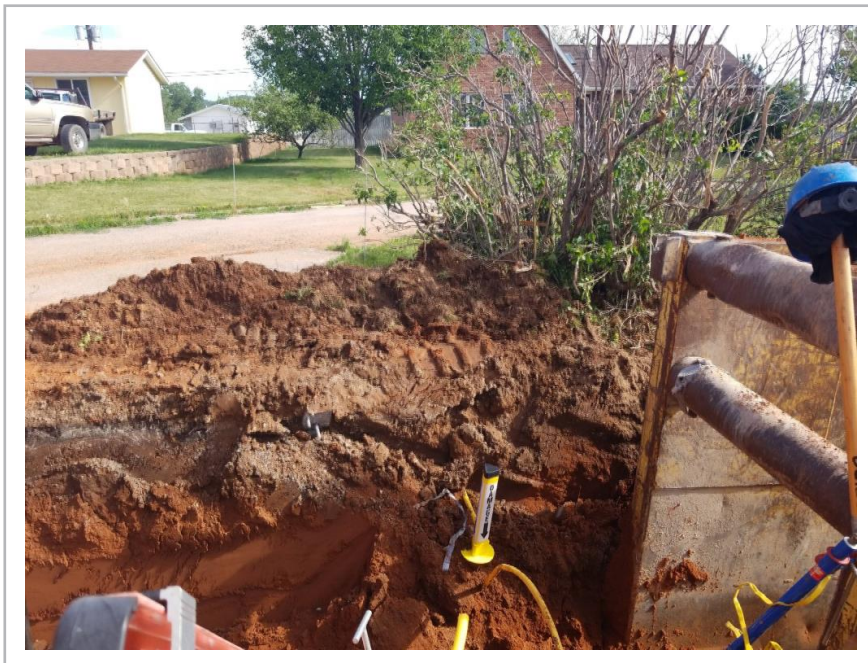
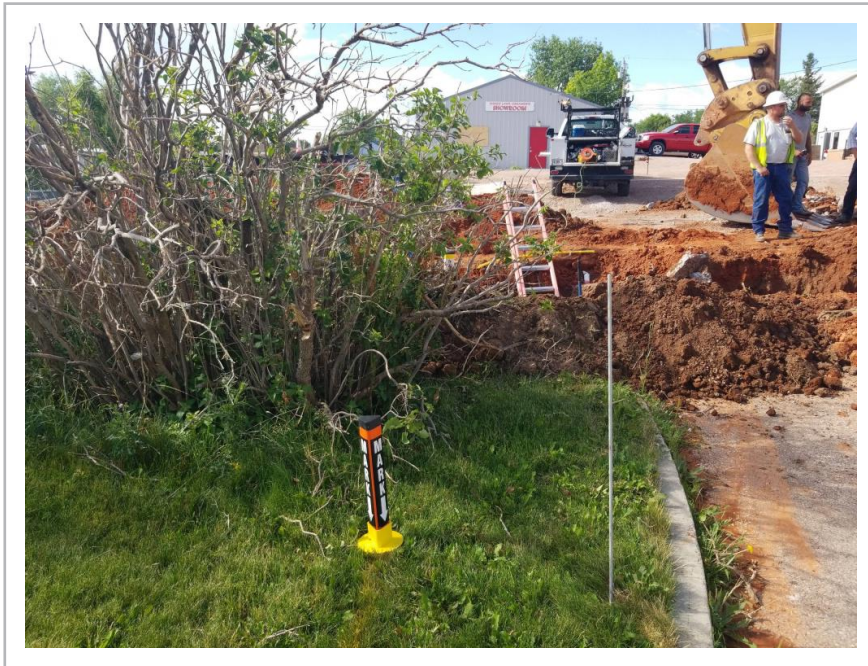
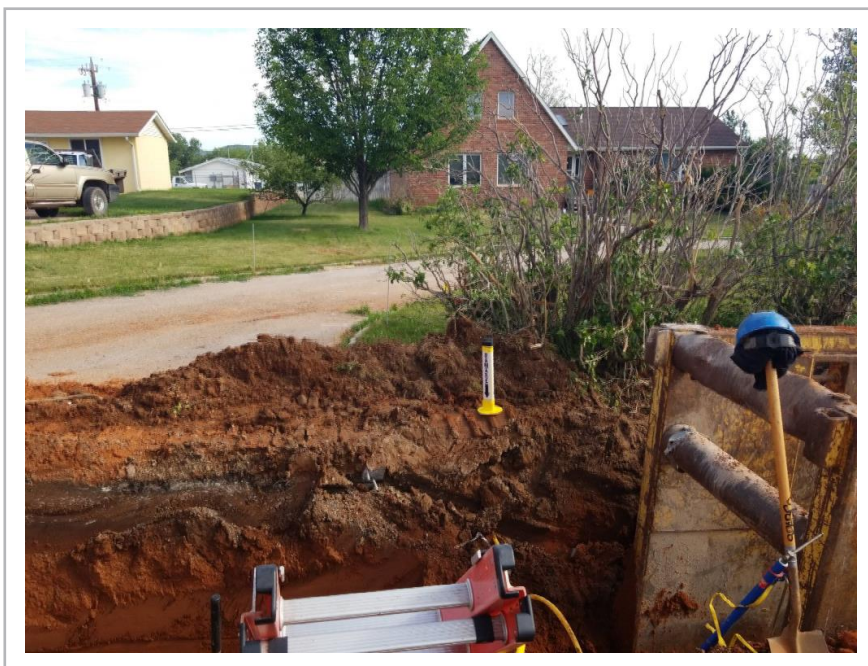
**Assessment Comments:** A MDU service line to 5500 Elm St was damaged July 20th around 7:30 am by a backhoe by Rapid Construction LLC. There are still locate Mark's on either side of the damaged line as well as 1 locate flag. The locate Mark's directly on either side of the trench have either been destroyed by the digging of the trench or are buried beneath soil from the trench. All the markings line up with the damaged MDU 3/4 inch plastic service. Pictures from the ticket 2019760274 of this service could not be found. Pictures of this service marked on the excavators prior ticket, 2017646630, have been included as well as photos of the existing marks.
