INCIDENT INVESTIGATION #195564

671 South St, Whitewood, SD

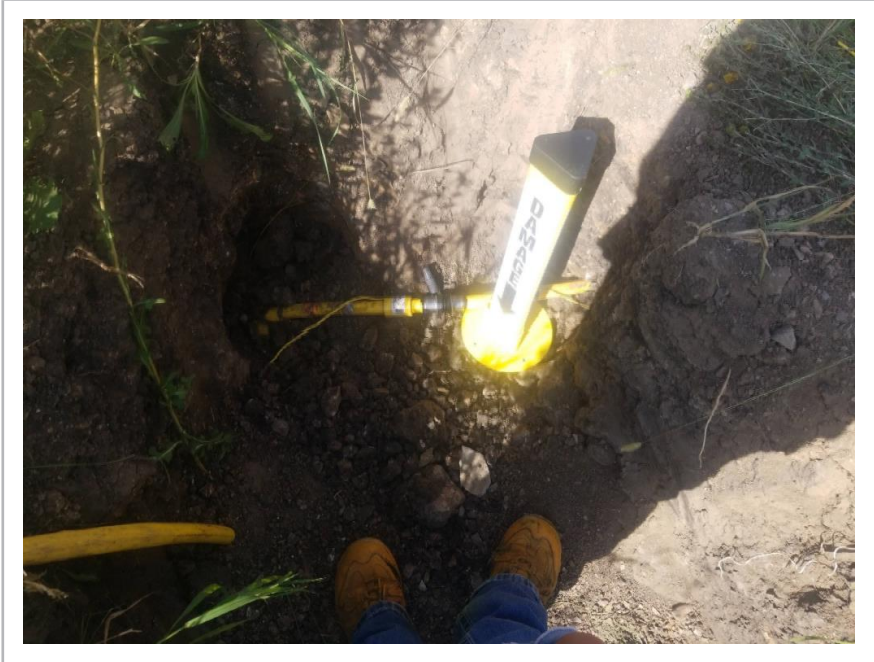
Assessment Comments: On August 12th at 3:00 MDU called and informed me that there was a gas line hit in White Wood SD. Using a backhoe the contractor had hit the MDU 3/4 inch plastic gas service line for 671 south st while trenching to add utilities for 673 south st. The contractor does not have a locate requested. Gas was not blowing do to a EFV. 811 was notified, 911 was not. Gas was just leaking when MDU tech arrived.
