## INCIDENT INVESTIGATION #198409

23605 Wilderness Canyon Rd, Rapid City, SD

**Line Size and Type:** 2" Plastic

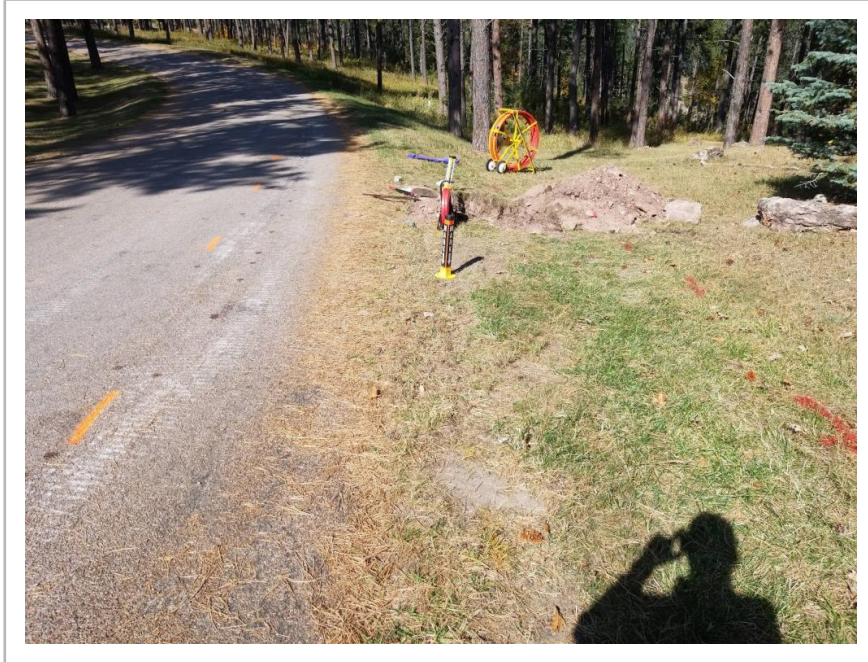
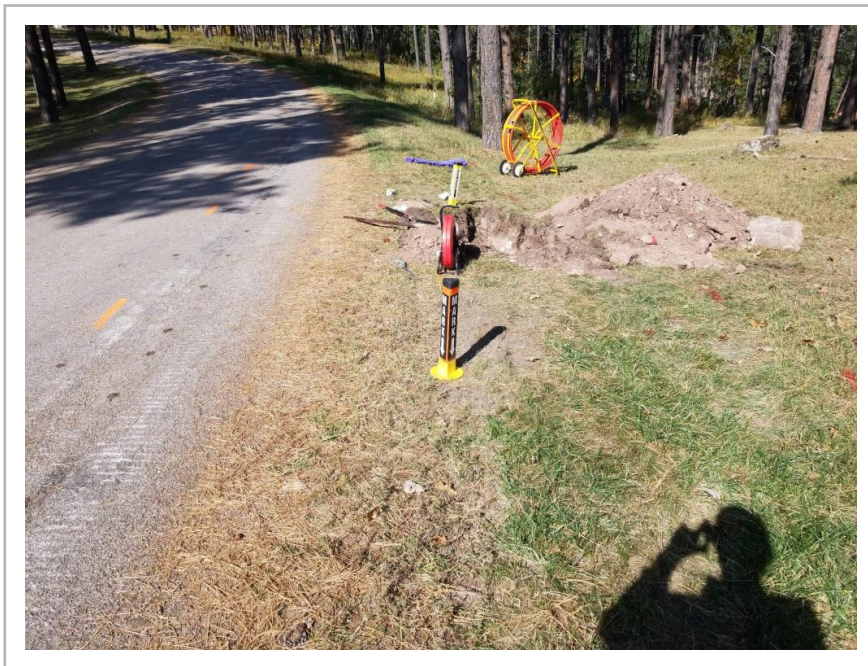
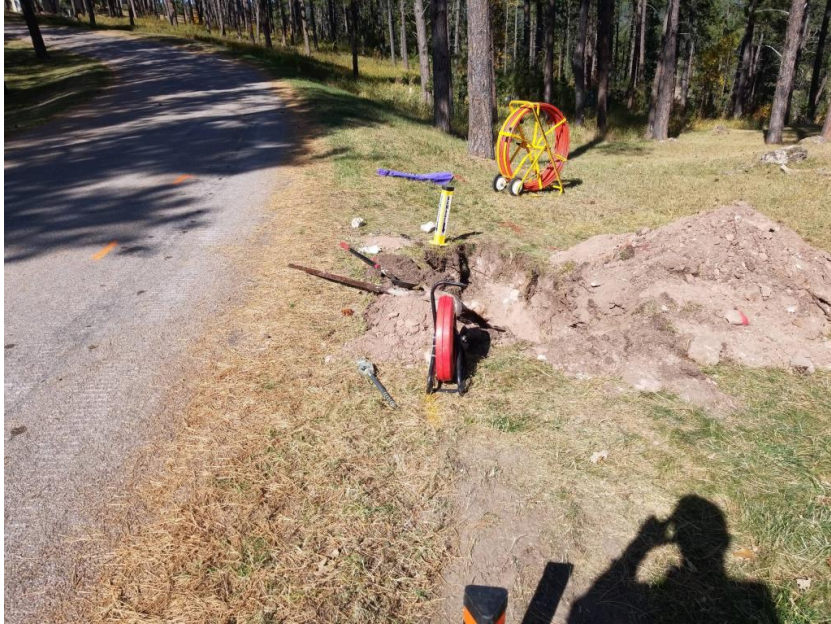
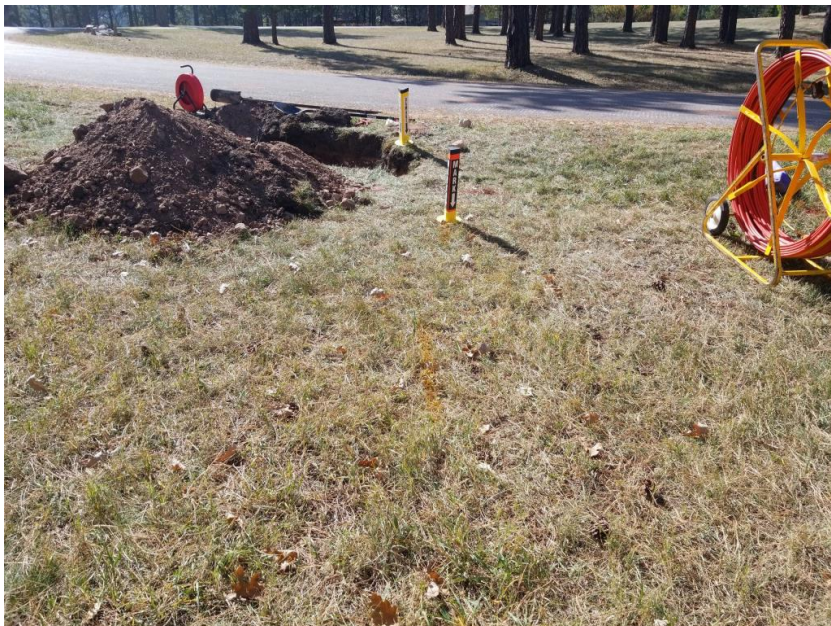
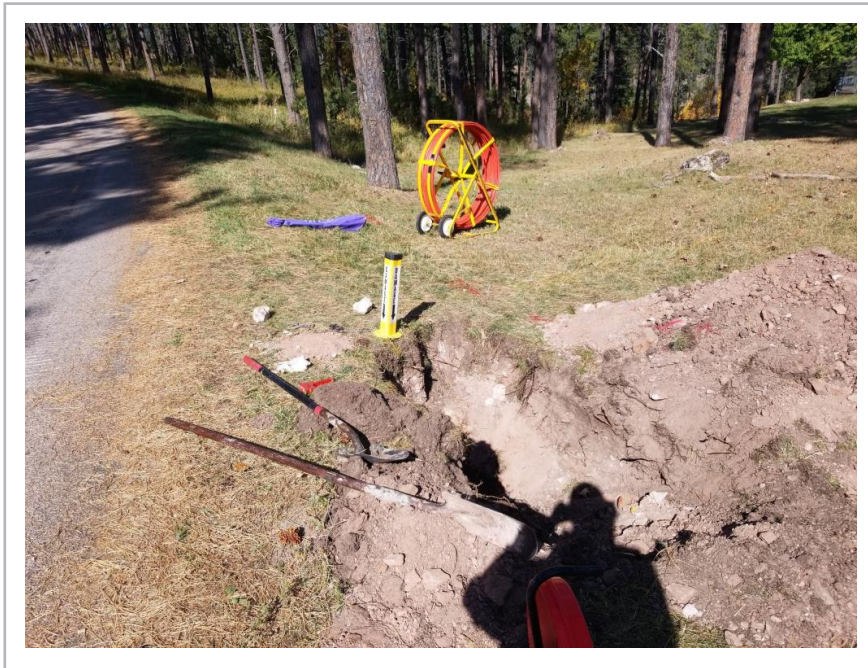
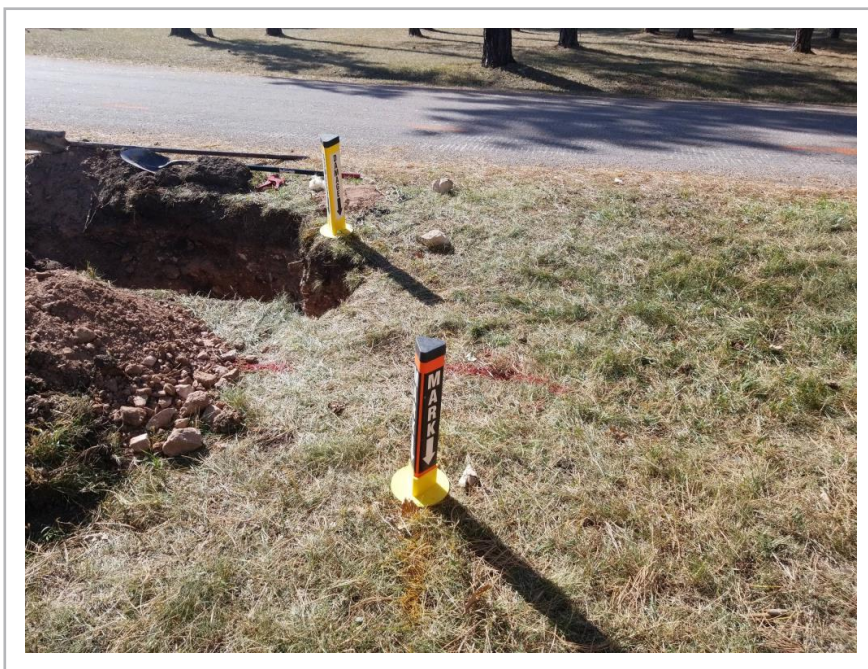
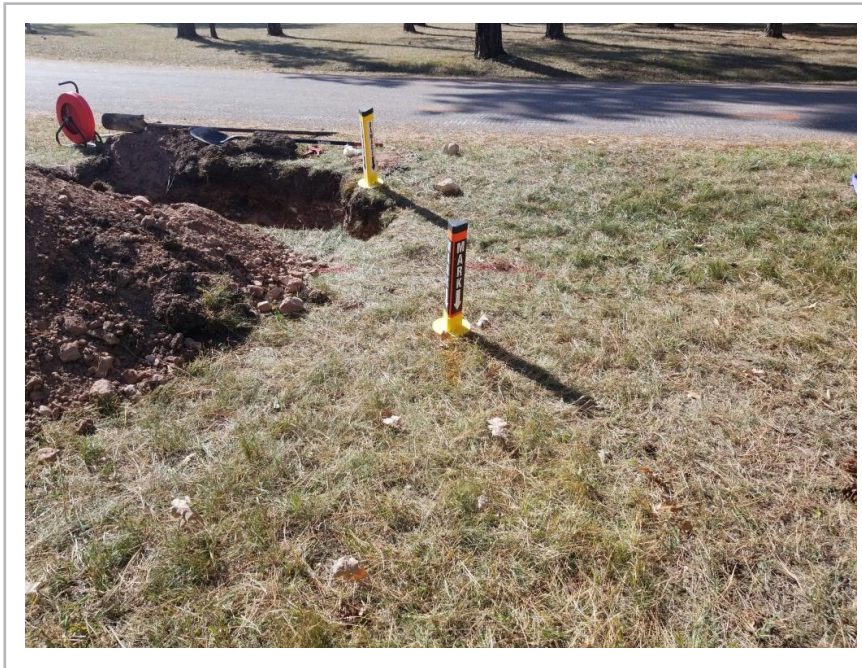
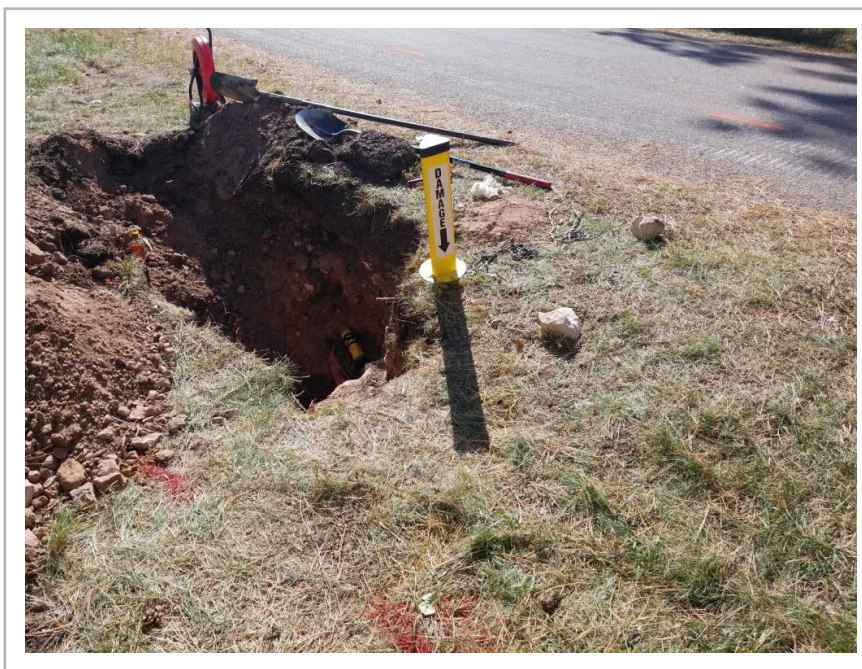
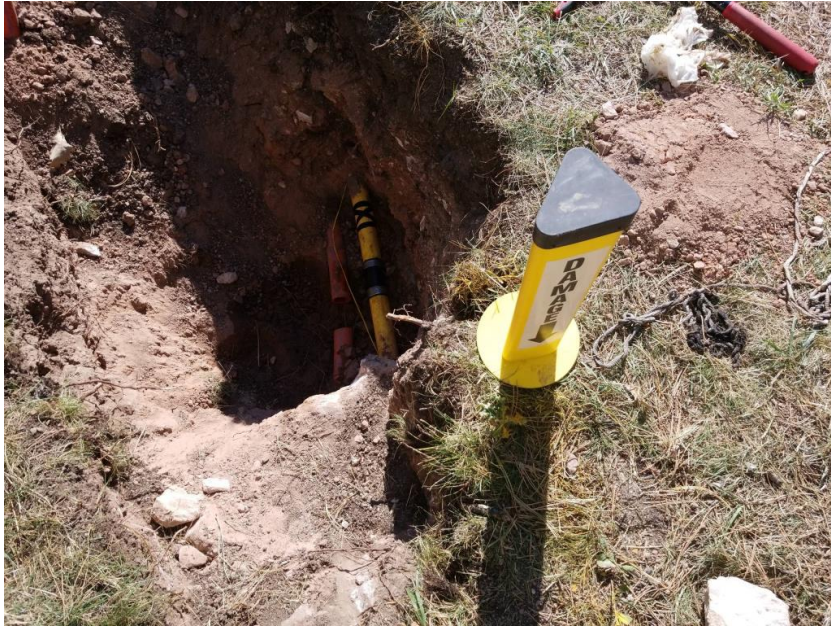
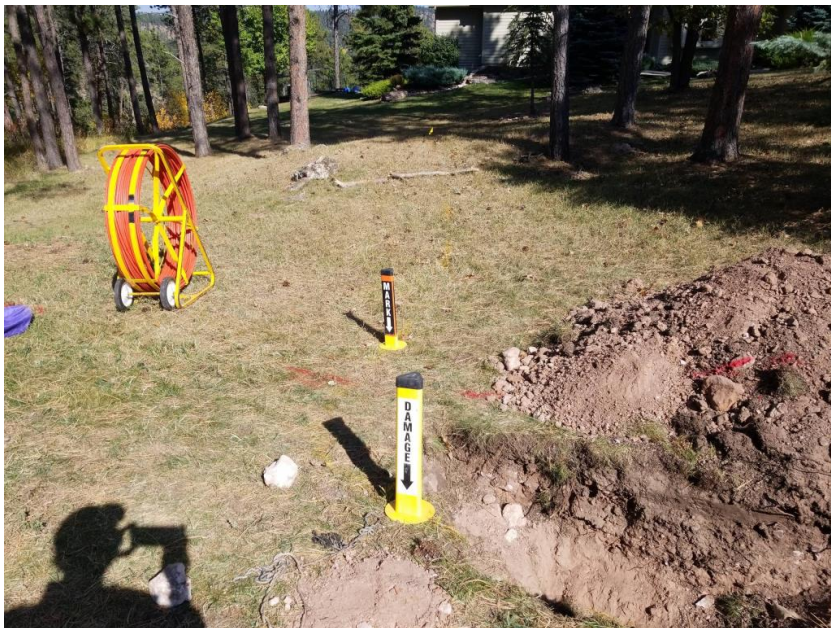
# NEW INCIDENT PHOTOS

**Assessment Comments:** Contractor didn't have a locate ticket in their name. They were working off the markings from some other contractors locates. The contractor punctured a hole in to the gas main when they were using the Mini excavator and a rock hit the line. Gas was blowing. 911 and 811 were notified.

**Facilities Replaced or Repaired:** Repaired
