## INCIDENT INVESTIGATION #201718

30 Adams St, Deadwood, SD

**Line Size and Type:** 2.00" Gas

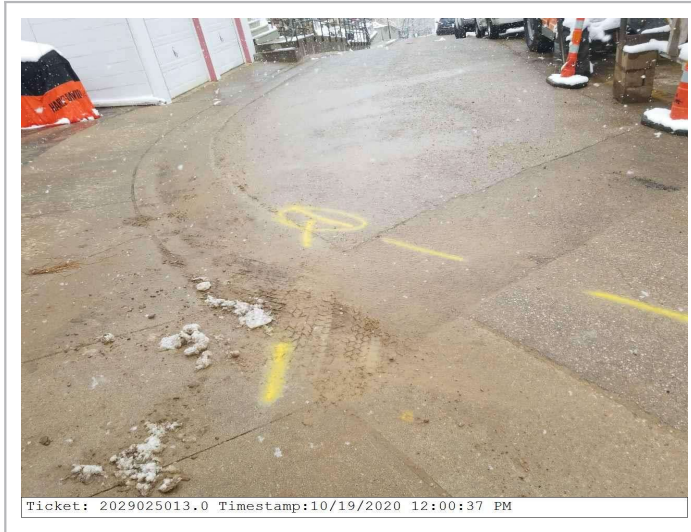
## SURVEY PHOTO

Date: 10/19/2020 11:00 AM  
America/Denver

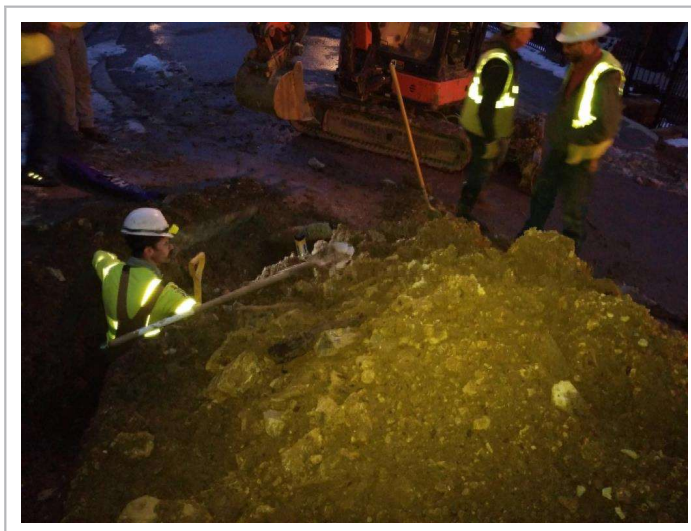
## INCIDENT COMPARISON PHOTO

**Root Cause:** Excavator dug prior to verifying marks by test-hole (pot-hole)

**Assessment Comments:** Locator was notified around 3:30 of gas damage that happened at 3pm. Gas was blowing. 911 was present with 3 fire trucks. Gas was shut off at 6:01pm. As of 7:00 gas line still had not been repaired. Will gather more information in the am. 8 mdu employees where present

Date: 10/28/2020 05:11 PM  
America/Denver

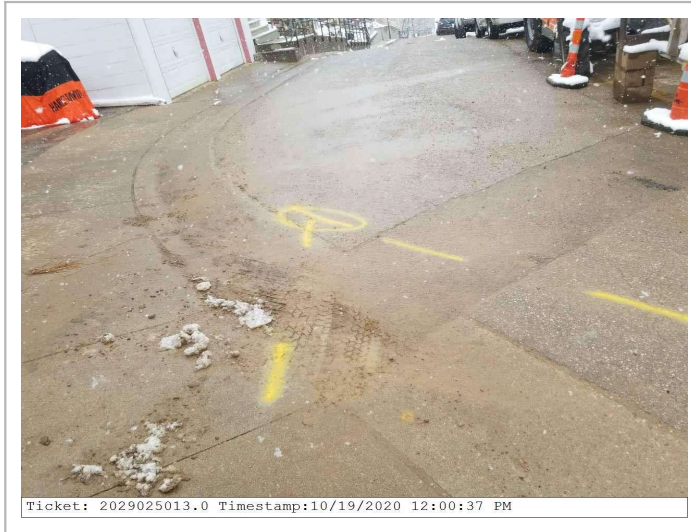
## SURVEY PHOTO

Date: 10/19/2020 11:00 AM  
America/Denver

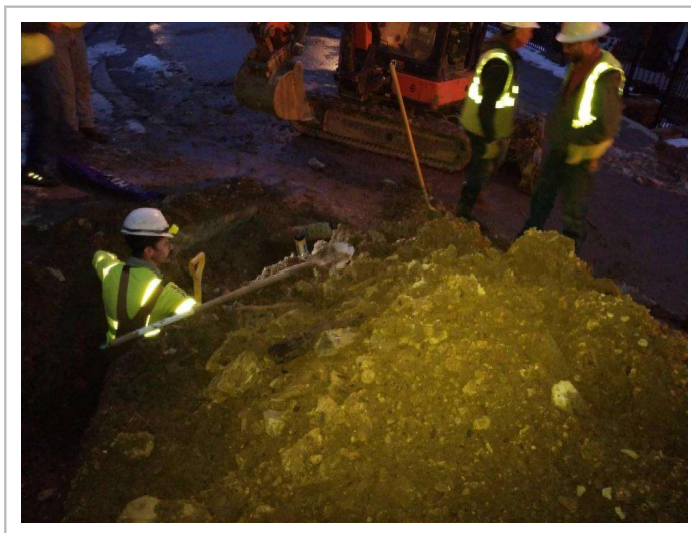
## INCIDENT COMPARISON PHOTO

**Root Cause:** Excavator dug prior to verifying marks by test-hole (pot-hole)

**Assessment Comments:** Locator was notified around 3:30 of gas damage that happened at 3pm. Gas was blowing. 911 was present with 3 fire trucks. Gas was shut off at 6:01pm. As of 7:00 gas line still had not been repaired. Will gather more information in the am. 8 mdu employees where present

Date: 10/28/2020 05:11 PM  
America/Denver
