## INCIDENT INVESTIGATION #201747

23608 Wilderness Canyon, Rapid City, SD

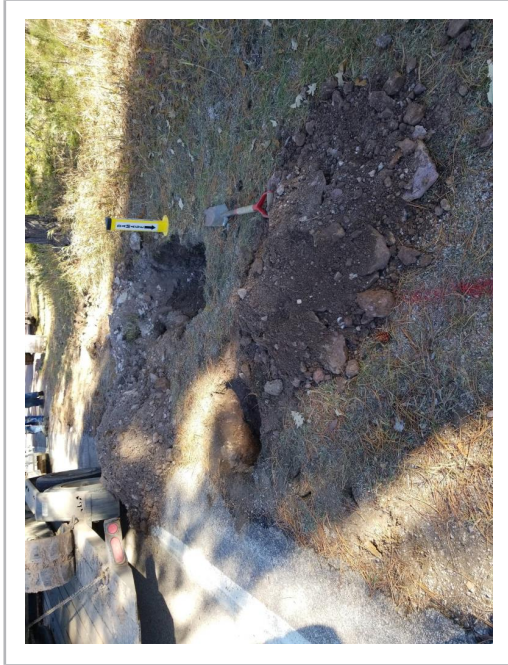
**Assessment Comments:** Contractor didn't have locates . They do not have a proper locate ticket in the area that were working in , they also did not have a proper damage locate ticket it does not state that the gas line was hit and the damage was on Wilderness Canyon at 23606 not.Silver Fox Spur. gas was blowing 911 and 811 were notified. The contractor using a Mini excavator was digging up existing conduits to try and locate a conduit for their cable TV in an area they do not have locates for where they hit the 3/4 inch Montana Dakota utilities plastic gas service.
